Access Compliance Report

Public Rights-of-Way

(Curb Ramps)

Intersection ID: 48519	Main Street: GALLERIA_BV	Cross Street: GALLERIA COURT DR	Location: NW
ADA ID: 2C0BA0D65B51	Ramp Type: PerpDiag	Initial Pass/Fail: Fail	Overall Compliance: No
			Severity Score: 33.75

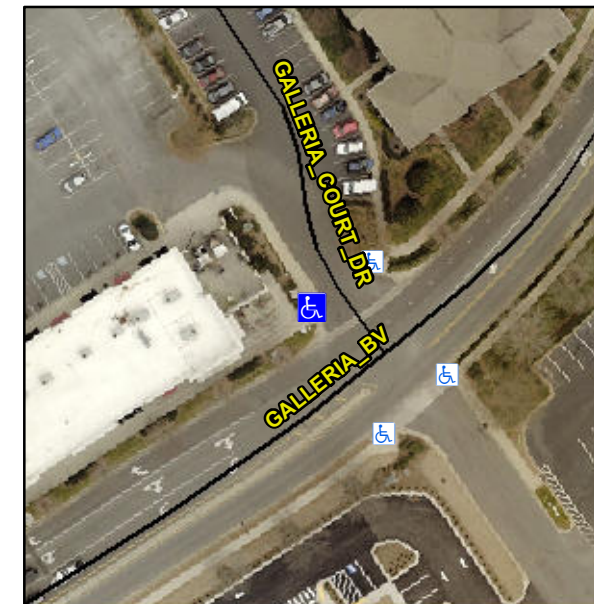
Compliance	Description	Data	Compliance	Description	Data
N/A	Ramp Length (in)	91.0	No	Ramp Slope (%)	11.1
No	Ramp Width (in)	47.0	No	Ramp XSlope (%)	5.8
N/A	Flare Type LT	N/A	N/A	Flare Type RT	N/A
N/A	Flare Slope LT (%)	N/A	N/A	Flare Slope RT (%)	N/A
N/A	Flare Traversable LT?	N/A	N/A	Flare Traversable RT?	N/A
N/A	Landing Length (in)	N/A	N/A	DWS Provided?	N/A
N/A	Landing Width (in)	N/A	N/A	DWS Contrast?	N/A
N/A	Landing Slope (%)	N/A	N/A	DWS Length (in)	N/A
N/A	Landing X Slope (%)	N/A	N/A	DWS Full Width?	N/A
N/A	Landing Curb? (Y/N)	N/A	N/A	DWS Offset (in)	N/A
N/A	Shared Landing?	N/A			
N/A	Gutter Ponding?	N/A	N/A	Gutter Slope (%)	N/A
N/A	Gutter Lip Ht (in)	N/A	N/A	Gutter X Slope (%)	N/A
N/A	Painted X Walk1?	No	N/A	Painted X Walk2?	No
	X Walk 1 Direction	To SE		X Walk 2 Direction	To NE
N/A	X Walk 1 Width (in)	N/A	N/A	X Walk 2 Width (in)	N/A
	X Walk 1 Slope (%)	7.9		X Walk 2 Slope (%)	3.8
	X Walk 1 X Slope (%)	0.1		X Walk 2 X Slope (%)	6.0

N/A	Ramp inside XWalk1?	N/A	N/A	Ramp inside XWalk2?	N/A
	Road Slope (%)	4.4	N/A	Clear Space?	N/A
	Road X Slope (%)	5.3	N/A	Clear Space to XWalk (in)	N/A
N/A	Any Obstructions?	N/A	N/A	Storm Grate/Utility Hazard?	N/A
	Obstruction Type			Storm Grate/Utility Type	
		N/A			N/A
			Yes	Surface Condition? (G/P)	Good

Possible Solutions:

Remove & Replace Curb Ramp With Two New Directional Ramps or Equivalent.

R304.5.1, R304.2.2, R304.5.3
