Access Compliance Report

Public Rights-of-Way

(Curb Ramps)

Intersection ID: 50596	Main Street: STREAM_ORCHID_LN	Cross Street: GRAY_WILLOW_RD	Location: SE
ADA ID: 2C0D79EB70A1	Ramp Type: Perp	Initial Pass/Fail: Fail	Overall Compliance: No
		Severity Score: 10

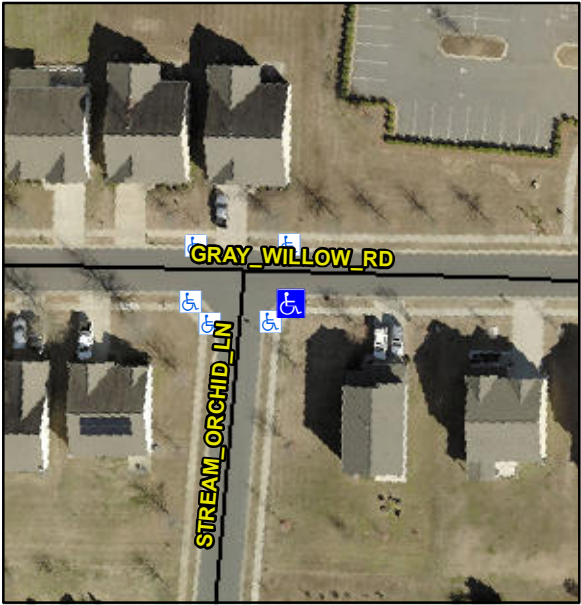
Possible Solutions:		Compliance	Description	Data
	Remove & Replace Entire Ramp.		Yes	Ramp Length (in)	7.8
			No	Ramp Width (in)	4.7
			N/A	Flare Type LT	N/A
			N/A	Flare Slope LT (%)	N/A
			N/A	Flare Traversable LT?	N/A
			N/A	Landing Length (in)	N/A
			N/A	Landing Width (in)	N/A
			N/A	Landing Slope (%)	N/A
			N/A	Landing X Slope (%)	N/A
			N/A	Landing Curb? (Y/N)	N/A
			N/A	Shared Landing?	N/A
			N/A	Gutter Ponding?	N/A
			N/A	Gutter Lip Ht (in)	N/A
			No	Painted X Walk1?	N/A
				X Walk 1 Direction	N/A
			N/A	X Walk 1 Width (in)	N/A
				X Walk 1 Slope (%)	N/A
				X Walk 1 X Slope (%)	N/A
			N/A	Ramp inside XWalk1?	N/A
<p>Surveyor Notes:</p> <p>N/A</p> <p>PROW/ADA:</p> <p>R304.5.1, R304.5.3</p>			N/A	Flare Type RT	N/A
			N/A	Flare Slope RT (%)	N/A
			N/A	Flare Traversable RT?	N/A
			N/A	DWS Provided?	N/A
			N/A	DWS Contrast?	N/A

N/A	DWS Length (in)	N/A
			N/A	DWS Full Width?	N/A
			N/A	DWS Offset (in)	N/A
			N/A	Gutter Slope (%)	N/A
			N/A	Gutter X Slope (%)	N/A
			N/A	Painted X Walk2?	N/A
				X Walk 2 Direction	N/A
			N/A	X Walk 2 Width (in)	N/A
				X Walk 2 Slope (%)	N/A
				X Walk 2 X Slope (%)	N/A
			N/A	Ramp inside XWalk2?	N/A
			N/A	Clear Space?	N/A
			N/A	Clear Space to XWalk (in)	N/A
			N/A	Storm Grate/Utility Hazard?	N/A
				Storm Grate/Utility Type	N/A
<p>Total Cost:</p> <p>\$ 1850.00</p>			N/A		N/A
			Yes	Surface Condition? (G/P)	Good
