Access Compliance Report

Public Rights-of-Way

(Curb Ramps)

Intersection ID: 43510	Main Street: MULBERRY_POND_DR	Cross Street: N/A	Location: S
ADA ID: 2C0DC1D45260	Ramp Type: PerpDiag	Initial Pass/Fail: Fail	Overall Compliance: No
Codes/Mitigation Info/Possible Solution		Field Measurements/Component Compliance	
		Severity Score: 10

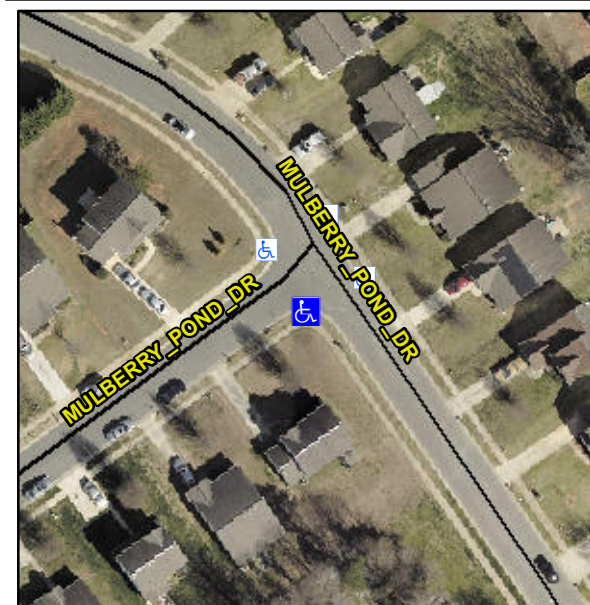
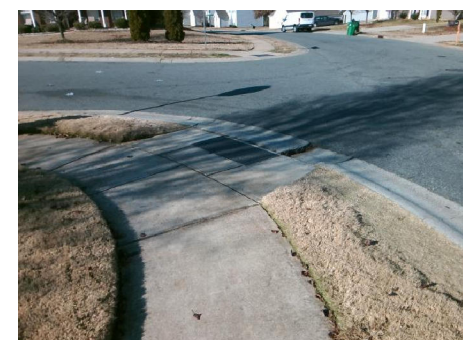
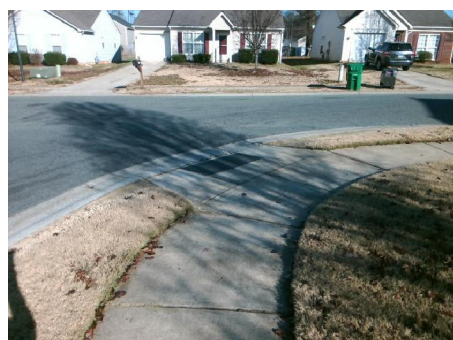
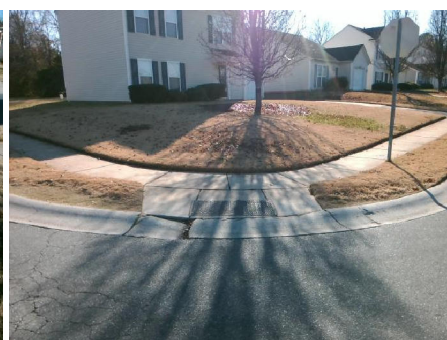
Not Found, R304.5.1, R304.5.3

Compliance	Description	Data	Compliance	Description	Data
N/A	Ramp Length (in)	48.0	Yes	Ramp Slope (%)	5.2
No	Ramp Width (in)	41.0	No	Ramp XSlope (%)	2.4
N/A	Flare Type LT	N/A	N/A	Flare Type RT	N/A
N/A	Flare Slope LT (%)	N/A	N/A	Flare Slope RT (%)	N/A
N/A	Flare Traversable LT?	N/A	N/A	Flare Traversable RT?	N/A
N/A	Landing Length (in)	N/A	N/A	DWS Provided?	N/A
N/A	Landing Width (in)	N/A	N/A	DWS Contrast?	N/A
N/A	Landing Slope (%)	N/A	N/A	DWS Length (in)	N/A
N/A	Landing X Slope (%)	N/A	N/A	DWS Full Width?	N/A
N/A	Landing Curb? (Y/N)	N/A	N/A	DWS Offset (in)	N/A
N/A	Shared Landing?	N/A			
N/A	Gutter Ponding?	N/A	N/A	Gutter Slope (%)	N/A
N/A	Gutter Lip Ht (in)	3.0	N/A	Gutter X Slope (%)	N/A
N/A	Painted X Walk1?	No	N/A	Painted X Walk2?	No
	X Walk 1 Direction	To NE		X Walk 2 Direction	To NW
N/A	X Walk 1 Width (in)	N/A	N/A	X Walk 2 Width (in)	N/A
	X Walk 1 Slope (%)	1.8		X Walk 2 Slope (%)	0.7
	X Walk 1 X Slope (%)	3.0		X Walk 2 X Slope (%)	0.4

N/A	Ramp inside XWalk1?	N/A	N/A	Ramp inside XWalk2?	N/A
	Road Slope (%)	1.7	N/A	Clear Space?	N/A
	Road X Slope (%)	0.1	N/A	Clear Space to XWalk (in)	N/A
N/A	Any Obstructions?	N/A	N/A	Storm Grate/Utility Hazard?	N/A
	Obstruction Type			Storm Grate/Utility Type	
		N/A			N/A
			Yes	Surface Condition? (G/P)	Good

Remove & Replace Curb Ramp With Two New Directional Ramps or Equivalent.
