Access Compliance Report Public Rights-of-Way (Curb Ramps)

Intersection ID: 24079 Main Street: LIVINGSTON MILL RD **Cross Street: MOSS RD** Location: NW ADA ID: 2C106C7A38CF Ramp Type: Perp Initial Pass/Fail: Pass **Overall Compliance: No Severity Score:** 15

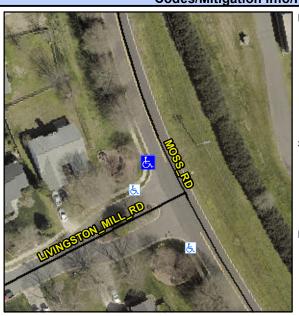
Field Measurements/Component Compliance						
	Compliance Description		Data	Compliance Description		Data
	N/A	Ramp Length (in)	97.0	Yes	Ramp Slope (%)	5.2
	Yes	Ramp Width (in)	48.0	Yes	Ramp XSlope (%)	0.0
	N/A	Flare Type LT	Sloped	N/A	Flare Type RT	N/A
	N/A	Flare Slope LT (%)	2.5	Yes	Flare Slope RT (%)	4.6
	N/A	Flare Traversable LT?	Yes	N/A	Flare Traversable RT?	Yes
	No	Landing Length (in)	N/A	Yes	DWS Provided?	Yes
	No	Landing Width (in)	N/A	Yes	DWS Contrast?	Yes
	No	Landing Slope (%)	N/A	Yes	DWS Length (in)	24.0
	No	Landing X Slope (%)	N/A	Yes	DWS Full Width?	Yes
	N/A	Landing Curb? (Y/N)	No	No	DWS Offset (in)	6.0
	N/A	Shared Landing?	No			
	Yes	Gutter Ponding?	No	No	Gutter Slope (%)	5.3
	Yes	Gutter Lip Ht (in)	0.0	Yes	Gutter X Slope (%)	1.8
	N/A	Painted X Walk1?	No	N/A	Painted X Walk2?	N/A
		X Walk 1 Direction	To NE		X Walk 2 Direction	N/A
	N/A	X Walk 1 Width (in)	N/A	N/A	X Walk 2 Width (in)	N/A
		X Walk 1 Slope (%)	6.7		X Walk 2 Slope (%)	N/A

X Walk 1 X Slope (%)	1.0		X Walk 2 X Slope (%)	N/A
	N/A	Ramp inside XWalk1?	N/A	N/A	Ramp inside XWalk2?	N/A
		Road Slope (%)	N/A	N/A	Clear Space?	Yes
		Road X Slope (%)	N/A	N/A	Clear Space to XWalk (in)	N/A
	Yes	Any Obstructions?	No	Yes	Storm Grate/Utility Hazard?	No
		Obstruction Type			Storm Grate/Utility Type	
			N/A			N/A
				Yes	Surface Condition? (G/P)	Good
_

MOSS RD Street 1 Name Stop Condition-Street 2 None Street 2 Name N/A Stop Condition-Street 1 N/A Possible Solutions: Remove & Replace Entire Ramp. Remove & Replace Gutter. Surveyor Notes: N/A PROW/ADA: R304.2.1, R304.2.2-Perp, R304.3.2-Para, R304.5.3, R305.2, R304.5.4
