Access Compliance Report

Public Rights-of-Way

| Intersection ID: 54461 | Main Street: FENWAY_DR | Cross Street: FLINT_HILL_DR | Location: NW |
| ADA ID: 2C16304219D6 | Ramp Type: Perp | Initial Pass/Fail: Pass | Overall Compliance: No |

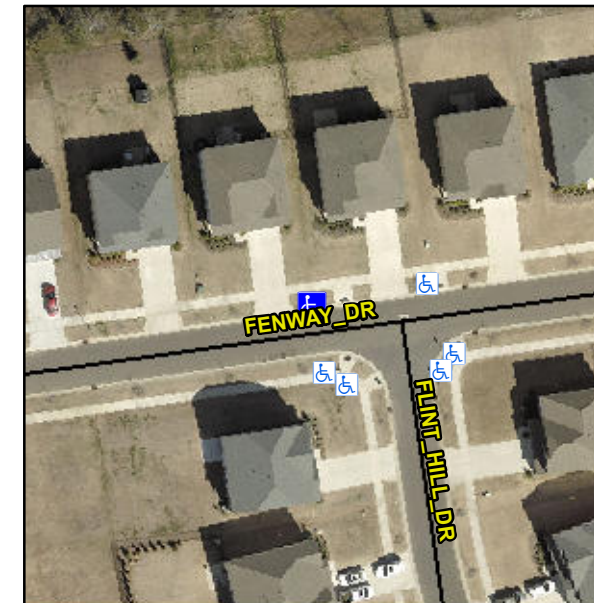
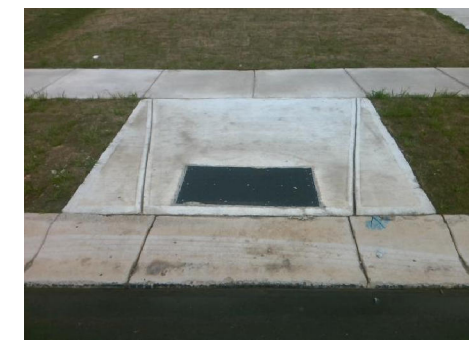
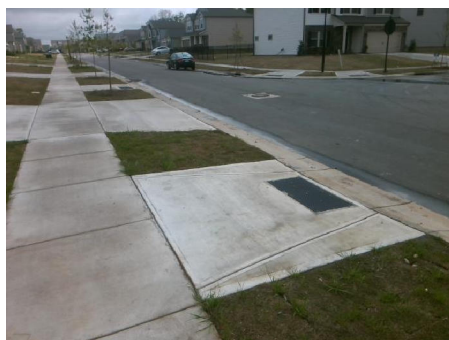
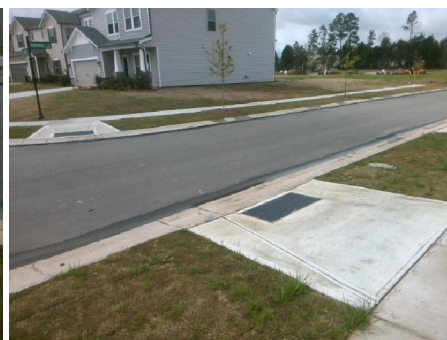
R305.2, R302.7.2

| Compliance | Description | Data | Compliance | Description | Data |
|---|---|---|---|---|---|
| N/A | Landing Curb? (Y/N) | No | No | DWS Offset (in) | 5.0 |
| No | Gutter Lip Ht (in) | 1.0 | Yes | Gutter X Slope (%) | 0.3 |

Remove & Replace Detectable Warning System. Grind Gutter Lip.
