Access Compliance Report

Public Rights-of-Way

(Curb Ramps)

Intersection ID: 45553	Main Street: MOUNTAIN_QUAIL_DR	Cross Street: ROOK_RD	Location: E
ADA ID: 2C1B681EB162	Ramp Type: PerpDiag	Initial Pass/Fail: Fail	Overall Compliance: No
Codes/Mitigation Info/Possible Solution		Field Measurements/Component Compliance	
Severity Score: 22.5

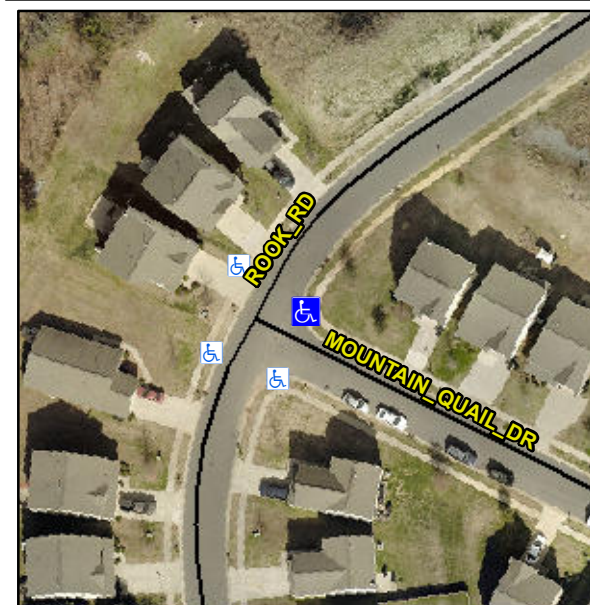
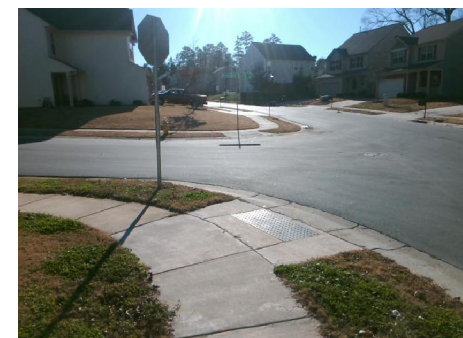
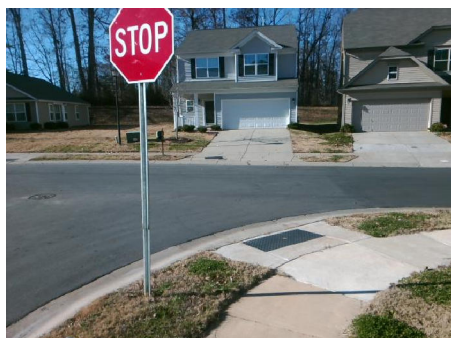
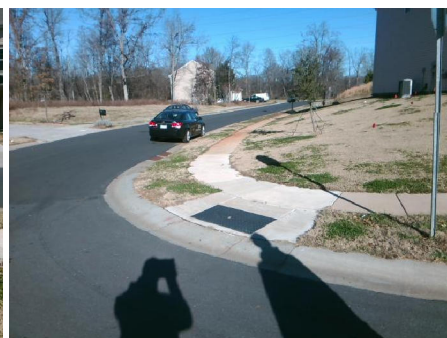
Not Found, R304.5.1, R304.2.2, R304.5.3

Compliance	Description	Data	Compliance	Description	Data
N/A	Ramp Length (in)	45.0	No	Ramp Slope (%)	8.8
No	Ramp Width (in)	47.5	No	Ramp XSlope (%)	2.5
N/A	Flare Type LT	N/A	N/A	Flare Type RT	N/A
N/A	Flare Slope LT (%)	N/A	N/A	Flare Slope RT (%)	N/A
N/A	Flare Traversable LT?	N/A	N/A	Flare Traversable RT?	N/A
N/A	Landing Length (in)	N/A	N/A	DWS Provided?	N/A
N/A	Landing Width (in)	N/A	N/A	DWS Contrast?	N/A
N/A	Landing Slope (%)	N/A	N/A	DWS Length (in)	N/A
N/A	Landing X Slope (%)	N/A	N/A	DWS Full Width?	N/A
N/A	Landing Curb? (Y/N)	N/A	N/A	DWS Offset (in)	N/A
N/A	Shared Landing?	N/A			
N/A	Gutter Ponding?	N/A	N/A	Gutter Slope (%)	N/A
N/A	Gutter Lip Ht (in)	N/A	N/A	Gutter X Slope (%)	N/A
N/A	Painted X Walk1?	No	N/A	Painted X Walk2?	No
	X Walk 1 Direction	To NW		X Walk 2 Direction	To SW
N/A	X Walk 1 Width (in)	N/A	N/A	X Walk 2 Width (in)	N/A
	X Walk 1 Slope (%)	1.8		X Walk 2 Slope (%)	0.8
	X Walk 1 X Slope (%)	2.4		X Walk 2 X Slope (%)	1.7

N/A	Ramp inside XWalk1?	N/A	N/A	Ramp inside XWalk2?	N/A
	Road Slope (%)	2.0	N/A	Clear Space?	N/A
	Road X Slope (%)	1.9	N/A	Clear Space to XWalk (in)	N/A
N/A	Any Obstructions?	N/A	N/A	Storm Grate/Utility Hazard?	N/A
	Obstruction Type			Storm Grate/Utility Type	
		N/A			N/A
			Yes	Surface Condition? (G/P)	Good

Remove & Replace Curb Ramp With Two New Directional Ramps or Equivalent.
