Access Compliance Report Public Rights-of-Way (Curb Ramps)

Intersection ID: 17742 Main Street: S_WENDOVER_RD Cross Street: PROVIDENCE_RD Location: SE

ADA ID: 2C27C06FE687 Ramp Type: PerpDiag Initial Pass/Fail: Fail Overall Compliance: No Severity Score: 22.5

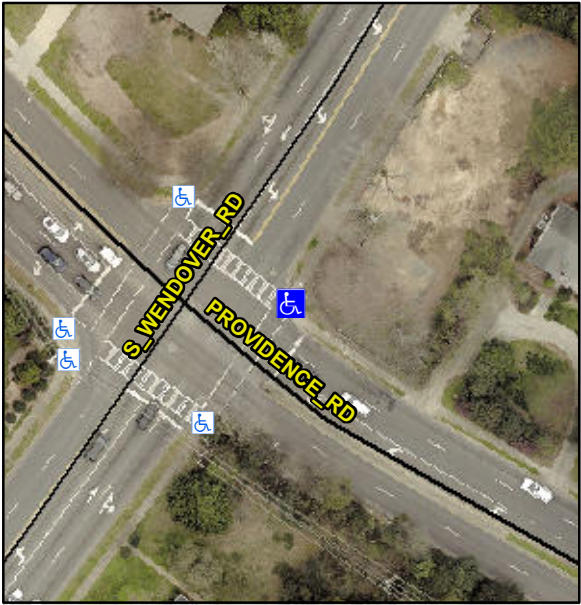
PROW/ADA:
Not Found, R304.5.1, R304.2.2, R304.5.3

Compliance	Description	Data	Compliance	Description	Data
N/A	Ramp Length (in)	50.0	No	Ramp Slope (%)	11.8
No	Ramp Width (in)	36.5	No	Ramp XSlope (%)	3.0
N/A	Flare Type LT	N/A	N/A	Flare Type RT	N/A
N/A	Flare Slope LT (%)	N/A	N/A	Flare Slope RT (%)	N/A
N/A	Flare Traversable LT?	N/A	N/A	Flare Traversable RT?	N/A
N/A	Landing Length (in)	N/A	N/A	DWS Provided?	N/A
N/A	Landing Width (in)	N/A	N/A	DWS Contrast?	N/A
N/A	Landing Slope (%)	N/A	N/A	DWS Length (in)	N/A
N/A	Landing X Slope (%)	N/A	N/A	DWS Full Width?	N/A
N/A	Landing Curb? (Y/N)	N/A	N/A	DWS Offset (in)	N/A
N/A	Shared Landing?	N/A			
N/A	Gutter Ponding?	N/A	N/A	Gutter Slope (%)	N/A
N/A	Gutter Lip Ht (in)	N/A	N/A	Gutter X Slope (%)	N/A
N/A	Painted X Walk1?	Yes	N/A	Painted X Walk2?	Yes
	X Walk 1 Direction	To NW		X Walk 2 Direction	To SW
N/A	X Walk 1 Width (in)	105.5	N/A	X Walk 2 Width (in)	102.5
	X Walk 1 Slope (%)	3.5		X Walk 2 Slope (%)	5.6
	X Walk 1 X Slope (%)	4.8		X Walk 2 X Slope (%)	1.9

N/A	Ramp inside XWalk1?	Yes	N/A	Ramp inside XWalk2?	Yes
	Road Slope (%)	1.4	N/A	Clear Space?	N/A
	Road X Slope (%)	8.7	N/A	Clear Space to XWalk (in)	N/A
N/A	Any Obstructions?	N/A	N/A	Storm Grate/Utility Hazard?	N/A
	Obstruction Type			Storm Grate/Utility Type	
		N/A			N/A
			Yes	Surface Condition? (G/P)	Good

Possible Solutions:
Remove & Replace Curb Ramp With Two New Directional Ramps or Equivalent.
