Access Compliance Report Public Rights-of-Way (Curb Ramps)

Intersection ID: 13149Main Street:CENTRAL_AVCross Street:THE_PLAZALocation:SWADA ID: 2C2C16524B50Ramp Type:PerpInitial Pass/Fail:FailOverall Compliance:NoSeverity Score:30

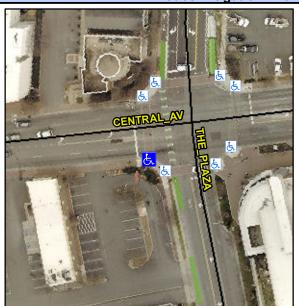
D/Possible Solution	ie Solution Field Measurements/Component Compilance						
Possible Solutions:	Compli	iance Description	Data	Compl	iance Description	Data	
Remove & Replace Entire Ramp.	N/A	Ramp Length (in)	68.5	No	Ramp Slope (%)	10.8	
	No	Ramp Width (in)	35.5	Yes	Ramp XSlope (%)	1.2	
	N/A	Flare Type LT	N/A	N/A	Flare Type RT	N/A	
	N/A	Flare Slope LT (%)	N/A	N/A	Flare Slope RT (%)	N/A	
	N/A	Flare Traversable LT?	N/A	N/A	Flare Traversable RT?	N/A	
	N/A	Landing Length (in)	N/A	N/A	DWS Provided?	N/A	
Surveyor Notes:	N/A	Landing Width (in)	N/A	N/A	DWS Contrast?	N/A	
N/A	N/A	Landing Slope (%)	N/A	N/A	DWS Length (in)	N/A	
	N/A	Landing X Slope (%)	N/A	N/A	DWS Full Width?	N/A	
	N/A	Landing Curb? (Y/N)	N/A	N/A	DWS Offset (in)	N/A	
	N/A	Shared Landing?	N/A				
PROW/ADA:	N/A	Gutter Ponding?	N/A	N/A	Gutter Slope (%)	N/A	
Not Found, R304.5.1, R304.2.2	N/A	Gutter Lip Ht (in)	N/A	N/A	Gutter X Slope (%)	N/A	
, i	N/A	Painted X Walk1?	Yes	N/A	Painted X Walk2?	N/A

X Walk 1 Direction	To N		X Walk 2 Direction	N/A	
	N/A	X Walk 1 Width (in)	96.0	N/A	X Walk 2 Width (in)	N/A	
		X Walk 1 Slope (%)	6.7		X Walk 2 Slope (%)	N/A	
		X Walk 1 X Slope (%)	0.3		X Walk 2 X Slope (%)	N/A	
	N/A	Ramp inside XWalk1?	Yes	N/A	Ramp inside XWalk2?	N/A	
		Road Slope (%)	N/A	N/A	Clear Space?	N/A	
		Road X Slope (%)	N/A	N/A	Clear Space to XWalk (in)	N/A	
	N/A	Any Obstructions?	N/A	N/A	Storm Grate/Utility Hazard?	N/A	
Total Cost: \$ 1850.00		Obstruction Type			Storm Grate/Utility Type		
			N/A			N/A
