# Access Compliance Report

## Public Rights-of-Way

### (Curb Ramps)

| Intersection ID: 15153 | Main Street: GRIFFITH_ST | Cross Street: POINDEXTER_DR | Location: | W |

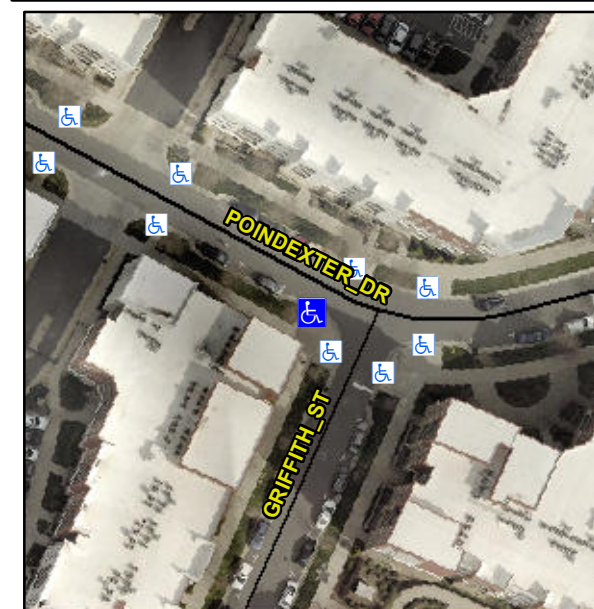
| ADA ID: 2C373D27CFDA | Ramp Type: Perp | Initial Pass/Fail: Fail | Overall Compliance: No | Severity Score: 12.5 |

**Not Found, R304.2.2**

| Compliance | Description | Data | Compliance | Description | Data |
|---|---|---|---|---|---|
| N/A | Ramp Length (in) | 75.0 | No | Ramp Slope (%) | 9.1 |

**Remove & Replace Entire Ramp.**

Total Cost: \$ 1850.00
