# Access Compliance Report

## Public Rights-of-Way

### (Curb Ramps)

Intersection ID: 48555	Main Street: COTTON_PRESS_RD	Cross Street: RIDGEFOREST_DR	Location: E
ADA ID: 2C376C8167A3	Ramp Type: PerpDiag	Initial Pass/Fail: Pass	Overall Compliance: No
		Severity Score: 7.5

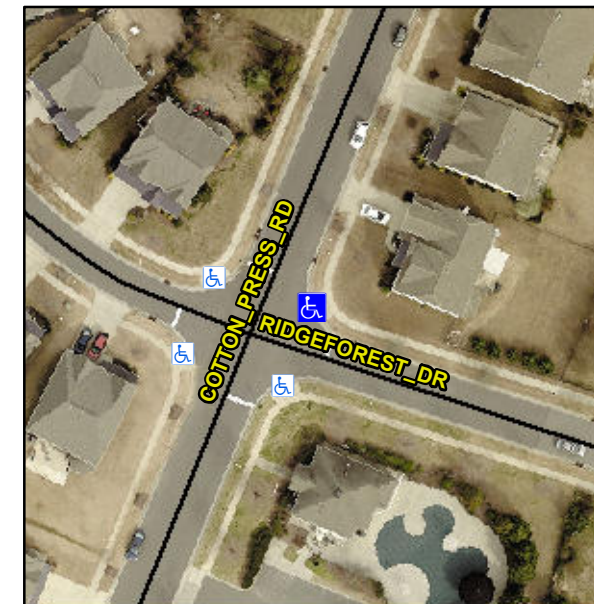
Compliance	Description	Data	Compliance	Description	Data
N/A	Ramp Length (in)	71.0	Yes	Ramp Slope (%)	6.3
Yes	Ramp Width (in)	48.0	Yes	Ramp XSlope (%)	1.8
N/A	Flare Type LT	Sloped	N/A	Flare Type RT	N/A
N/A	Flare Slope LT (%)	5.2	Yes	Flare Slope RT (%)	5.3
N/A	Flare Traversable LT?	Yes	N/A	Flare Traversable RT?	Yes
Yes	Landing Length (in)	48.0	Yes	DWS Provided?	Yes
Yes	Landing Width (in)	48.0	Yes	DWS Contrast?	Yes
Yes	Landing Slope (%)	0.5	Yes	DWS Length (in)	24.5
Yes	Landing X Slope (%)	1.2	Yes	DWS Full Width?	Yes
N/A	Landing Curb? (Y/N)	No	Yes	DWS Offset (in)	1.0
N/A	Shared Landing?	No			
Yes	Gutter Ponding?	No	Yes	Gutter Slope (%)	1.9
No	Gutter Lip Ht (in)	0.5	Yes	Gutter X Slope (%)	0.2
N/A	Painted X Walk1?	No	N/A	Painted X Walk2?	No
	X Walk 1 Direction	To NW		X Walk 2 Direction	To SW
N/A	X Walk 1 Width (in)	N/A	N/A	X Walk 2 Width (in)	N/A
	X Walk 1 Slope (%)	1.4		X Walk 2 Slope (%)	0.7
	X Walk 1 X Slope (%)	0.5		X Walk 2 X Slope (%)	1.3

N/A	Ramp inside XWalk1?	N/A	N/A	Ramp inside XWalk2?	N/A
	Road Slope (%)	0.5	N/A	Clear Space?	Yes
	Road X Slope (%)	1.5	N/A	Clear Space to XWalk (in)	N/A
Yes	Any Obstructions?	No	Yes	Storm Grate/Utility Hazard?	No
	Obstruction Type			Storm Grate/Utility Type	
		N/A			N/A
			Yes	Surface Condition? (G/P)	Good

Possible Solutions:

**Grind Gutter Lip.**

PROW/ADA:

**R302.7.2**

Total Cost:

**\$ 200.00**
