Access Compliance Report

Public Rights-of-Way

(Curb Ramps)

Intersection ID: 42560	Main Street: GLENWOOD_DR	Cross Street: N_I-85_EXIT_35_RA	Location: N
ADA ID: 2C409E5EAE9C	Ramp Type: Perp	Initial Pass/Fail: Fail	Overall Compliance: No
Severity Score: 33.75			
Codes/Mitigation Info/Possible Solution		Field Measurements/Component Compliance

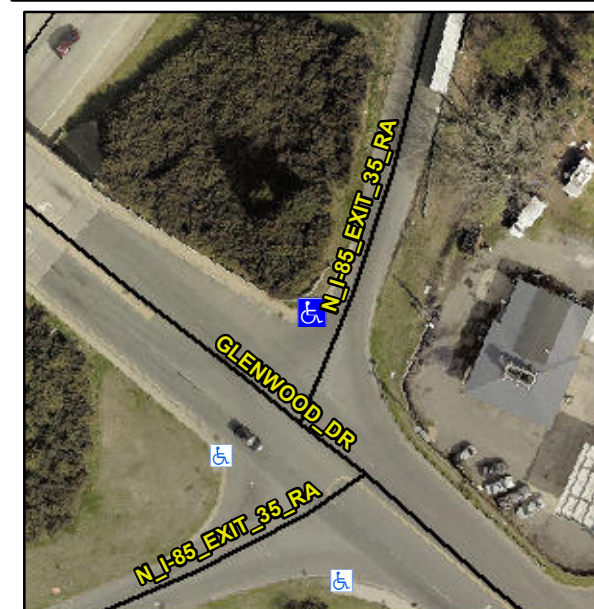
Not Found, R304.5.1, R304.2.2, R304.5.3

Compliance	Description	Data	Compliance	Description	Data
N/A	Ramp Length (in)	55.0	No	Ramp Slope (%)	9.9
No	Ramp Width (in)	42.0	No	Ramp XSlope (%)	5.5
N/A	Flare Type LT	N/A	N/A	Flare Type RT	N/A
N/A	Flare Slope LT (%)	N/A	N/A	Flare Slope RT (%)	N/A
N/A	Flare Traversable LT?	N/A	N/A	Flare Traversable RT?	N/A
N/A	Landing Length (in)	N/A	N/A	DWS Provided?	N/A
N/A	Landing Width (in)	N/A	N/A	DWS Contrast?	N/A
N/A	Landing Slope (%)	N/A	N/A	DWS Length (in)	N/A
N/A	Landing X Slope (%)	N/A	N/A	DWS Full Width?	N/A
N/A	Landing Curb? (Y/N)	N/A	N/A	DWS Offset (in)	N/A
N/A	Shared Landing?	N/A			
N/A	Gutter Ponding?	N/A	N/A	Gutter Slope (%)	N/A
N/A	Gutter Lip Ht (in)	0.5	N/A	Gutter X Slope (%)	N/A
N/A	Painted X Walk1?	No	N/A	Painted X Walk2?	N/A
	X Walk 1 Direction	To SE		X Walk 2 Direction	N/A
N/A	X Walk 1 Width (in)	N/A	N/A	X Walk 2 Width (in)	N/A
	X Walk 1 Slope (%)	1.2		X Walk 2 Slope (%)	N/A
	X Walk 1 X Slope (%)	2.9		X Walk 2 X Slope (%)	N/A

N/A	Ramp inside XWalk1?	N/A	N/A	Ramp inside XWalk2?	N/A
	Road Slope (%)	2.9	N/A	Clear Space?	N/A
	Road X Slope (%)	1.2	N/A	Clear Space to XWalk (in)	N/A
N/A	Any Obstructions?	N/A	N/A	Storm Grate/Utility Hazard?	N/A
	Obstruction Type			Storm Grate/Utility Type	
		N/A			N/A
			Yes	Surface Condition? (G/P)	Good

Possible Solutions:

Remove & Replace Entire Ramp.

Total Cost: \$ 1850.00
