# Access Compliance Report

## Public Rights-of-Way

### (Curb Ramps)

| Intersection ID: 47845 | Main Street: DEL_RIO_RD | Cross Street: CACTUS_VALLEY_RD | Location: NE |

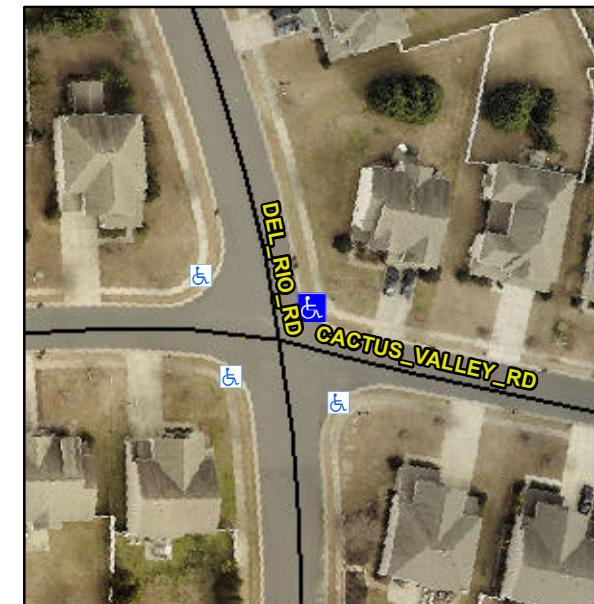
| ADA ID: 2C49089DBA8E | Ramp Type: PerpDiag | Initial Pass/Fail: Fail | Overall Compliance: No |
| Severity Score: 22.5 | | | |

**Not Found, R304.5.1, R304.2.2, R304.5.3**

| Compliance | Description | Data | Compliance | Description | Data |
|---|---|---|---|---|---|
| N/A | Ramp Length (in) | 64.0 | No | Ramp Slope (%) | 8.4 |
| No | Ramp Width (in) | 46.0 | No | Ramp XSlope (%) | 4.6 |

**Remove & Replace Curb Ramp With Two New Directional Ramps or Equivalent.**

Total Cost: \$ 3200.00
