Access Compliance Report

Public Rights-of-Way

(Curb Ramps)

Intersection ID: 2913	Main Street: CREEK_BREEZE_RD	Cross Street: MEADOWVIEW_HILLS_DR	Location: NW
ADA ID: 2C4AE7C10288	Ramp Type: PerpDiag	Initial Pass/Fail: Fail	Overall Compliance: No
Severity Score: 13.75			
Codes/Mitigation Info/Possible Solution		Field Measurements/Component Compliance

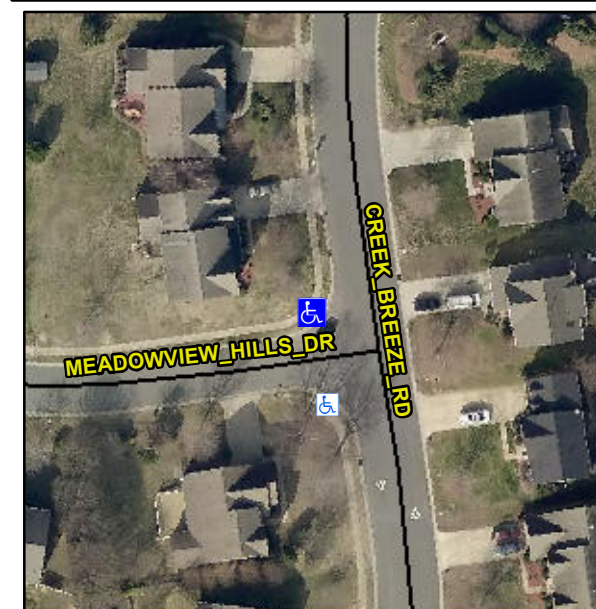
Not Found, R304.2.2, R304.5.3

Compliance	Description	Data	Compliance	Description	Data
N/A	Ramp Length (in)	46.0	No	Ramp Slope (%)	10.5
Yes	Ramp Width (in)	52.0	No	Ramp XSlope (%)	5.0
N/A	Flare Type LT	N/A	N/A	Flare Type RT	N/A
N/A	Flare Slope LT (%)	N/A	N/A	Flare Slope RT (%)	N/A
N/A	Flare Traversable LT?	N/A	N/A	Flare Traversable RT?	N/A
N/A	Landing Length (in)	N/A	N/A	DWS Provided?	N/A
N/A	Landing Width (in)	N/A	N/A	DWS Contrast?	N/A
N/A	Landing Slope (%)	N/A	N/A	DWS Length (in)	N/A
N/A	Landing X Slope (%)	N/A	N/A	DWS Full Width?	N/A
N/A	Landing Curb? (Y/N)	N/A	N/A	DWS Offset (in)	N/A
N/A	Shared Landing?	N/A			
N/A	Gutter Ponding?	N/A	N/A	Gutter Slope (%)	N/A
N/A	Gutter Lip Ht (in)	N/A	N/A	Gutter X Slope (%)	N/A
N/A	Painted X Walk1?	No	N/A	Painted X Walk2?	No
	X Walk 1 Direction	To E		X Walk 2 Direction	To S
N/A	X Walk 1 Width (in)	N/A	N/A	X Walk 2 Width (in)	N/A
	X Walk 1 Slope (%)	2.3		X Walk 2 Slope (%)	3.1
	X Walk 1 X Slope (%)	1.5		X Walk 2 X Slope (%)	4.6

N/A	Ramp inside XWalk1?	N/A	N/A	Ramp inside XWalk2?	N/A
	Road Slope (%)	3.2	N/A	Clear Space?	N/A
	Road X Slope (%)	2.9	N/A	Clear Space to XWalk (in)	N/A
N/A	Any Obstructions?	N/A	N/A	Storm Grate/Utility Hazard?	N/A
	Obstruction Type			Storm Grate/Utility Type	
		N/A			N/A
			Yes	Surface Condition? (G/P)	Good

Remove & Replace Curb Ramp With Two New Directional Ramps or Equivalent.
