# Access Compliance Report

## Public Rights-of-Way

### (Curb Ramps)

| Intersection ID: 26423 | Main Street: BEVINGTON_PL | Cross Street: SILVER_PINE_DR | Location: NE |

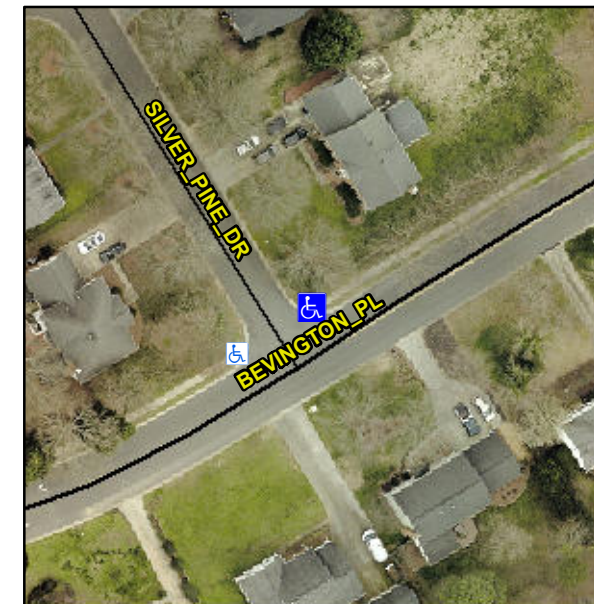
**Not Found, R304.2.2, R304.5.3**

| Compliance | Description | Data | Compliance | Description | Data |
|---|---|---|---|---|---|
| N/A | Ramp Length (in) | 30.0 | No | Ramp Slope (%) | 8.8 |
| Yes | Ramp Width (in) | 48.0 | No | Ramp XSlope (%) | 10.1 |

**Remove & Replace Curb Ramp With Two New Directional Ramps or Equivalent.**

Total Cost: \$ 3200.00
