Access Compliance Report

Public Rights-of-Way

(Curb Ramps)

Intersection ID: 12928	Main Street: PENMAN_ST	Cross Street: QUINCEY_ST	Location: W
ADA ID: 2C7F695CAF2A	Ramp Type: PerpDiag	Initial Pass/Fail: Fail	Overall Compliance: No
			Severity Score: 13.75

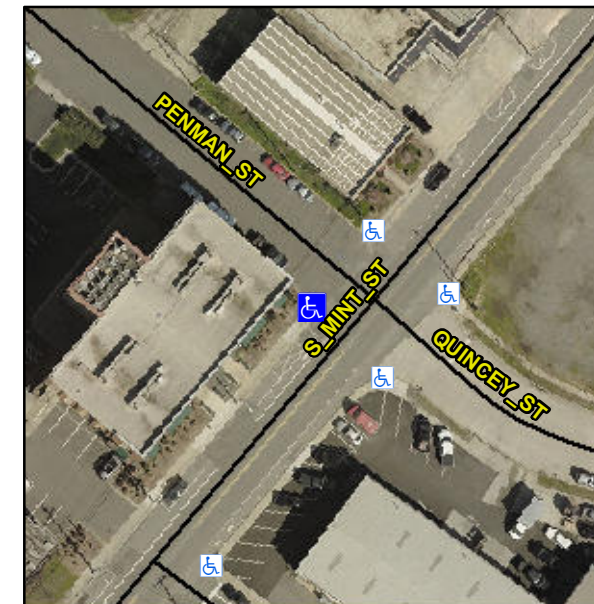
Not Found, R304.2.2, R304.5.3

Compliance	Description	Data	Compliance	Description	Data
N/A	Ramp Length (in)	27.0	No	Ramp Slope (%)	10.1
Yes	Ramp Width (in)	48.0	No	Ramp XSlope (%)	2.5
N/A	Flare Type LT	N/A	N/A	Flare Type RT	N/A
N/A	Flare Slope LT (%)	N/A	N/A	Flare Slope RT (%)	N/A
N/A	Flare Traversable LT?	N/A	N/A	Flare Traversable RT?	N/A
N/A	Landing Length (in)	N/A	N/A	DWS Provided?	N/A
N/A	Landing Width (in)	N/A	N/A	DWS Contrast?	N/A
N/A	Landing Slope (%)	N/A	N/A	DWS Length (in)	N/A
N/A	Landing X Slope (%)	N/A	N/A	DWS Full Width?	N/A
N/A	Landing Curb? (Y/N)	N/A	N/A	DWS Offset (in)	N/A
N/A	Shared Landing?	N/A			
N/A	Gutter Ponding?	N/A	N/A	Gutter Slope (%)	N/A
N/A	Gutter Lip Ht (in)	N/A	N/A	Gutter X Slope (%)	N/A
N/A	Painted X Walk1?	No	N/A	Painted X Walk2?	No
	X Walk 1 Direction	To SE		X Walk 2 Direction	To NE
N/A	X Walk 1 Width (in)	N/A	N/A	X Walk 2 Width (in)	N/A
	X Walk 1 Slope (%)	6.0		X Walk 2 Slope (%)	3.1
	X Walk 1 X Slope (%)	0.2		X Walk 2 X Slope (%)	1.4

N/A	Ramp inside XWalk1?	N/A	N/A	Ramp inside XWalk2?	N/A
	Road Slope (%)	3.2	N/A	Clear Space?	N/A
	Road X Slope (%)	5.5	N/A	Clear Space to XWalk (in)	N/A
N/A	Any Obstructions?	N/A	N/A	Storm Grate/Utility Hazard?	N/A
	Obstruction Type			Storm Grate/Utility Type	
		N/A			N/A
			Yes	Surface Condition? (G/P)	Good

Remove & Replace Curb Ramp With Two New Directional Ramps or Equivalent.
