Access Compliance Report Public Rights-of-Way (Curb Ramps)

Intersection ID: 13914	Itersection ID: 13914 Main Street: CHESTERFIELD_AV Cross Street: WESTOVER_ST					Location:	w	
ADA ID: 2C86EE8A91E4 Ramp Type: PerpDiag		Initial Pass/	nitial Pass/Fail: Fail Overall Compliance: No			o Severity Score:	21.25	
Codes/Mitigation Info/Possible Solution			Field Measurements/Component Compliance					
	Possible Solutions:	Com	Compliance Description		Data Compliance Description		Data	
	Remove & Replace Curb Ramp \	Vith N/A	Ramp Length (in)	60.0	No	Ramp Slope (%)	11.1	
	Two New Directional Ramps or	No	Ramp Width (in)	39.5	Yes	Ramp XSlope (%)	0.9	
	Equivalent.	N/A	Flare Type LT	N/A	N/A	Flare Type RT	N/A	
	The file	N/A	Flare Slope LT (%)	N/A	N/A	Flare Slope RT (%)	N/A	
A CONTRACTOR OF A CONTRACTOR O		N/A	Flare Traversable LT?	N/A	N/A	Flare Traversable RT?	N/A	
AVE		N/A	Landing Length (in)	N/A	N/A	DWS Provided?	N/A	
The second se	Surveyor Notes:	N/A	Landing Width (in)	N/A	N/A	DWS Contrast?	N/A

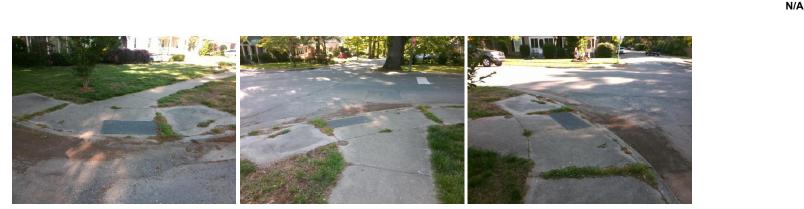
to the second second	N/A	N/A	Landing Slope (%)	N/A	N/A	DWS Length (in)	N/A	
		N/A	Landing X Slope (%)	N/A	N/A	DWS Full Width?	N/A	
1 1 28 78		N/A	Landing Curb? (Y/N)	N/A	N/A	DWS Offset (in)	N/A	
A A RELIERALSE	a C	N/A	Shared Landing?	N/A				
5-7191	PROW/ADA:	N/A	Gutter Ponding?	Yes	N/A	Gutter Slope (%)	N/A	
	R304.5.1, R304.2.2	N/A	Gutter Lip Ht (in)	N/A	N/A	Gutter X Slope (%)	N/A

1.	N/A	Painted X Walk1?	No	N/A	Painted X Walk2?	No	
			X Walk 1 Direction	To NE		X Walk 2 Direction	To SE	
L'ARTA IN STREET		N/A	X Walk 1 Width (in)	N/A	N/A	X Walk 2 Width (in)	N/A	
Street 1 Name WESTO	OVER ST		X Walk 1 Slope (%)	0.2		X Walk 2 Slope (%)	1.2	
Stop Condition-Street 2 S	stopSign		X Walk 1 X Slope (%)	0.7		X Walk 2 X Slope (%)	2.6	
Street 2 Name CHESTERF	IELD AV	N/A	Ramp inside XWalk1?	N/A	N/A	Ramp inside XWalk2?	N/A	
Stop Condition-Street 1 S	stopSign		Road Slope (%)	0.7	N/A	Clear Space?	N/A	
			Road X Slope (%)	0.5	N/A	Clear Space to XWalk (in)	N/A	
		N/A	Any Obstructions?	N/A	N/A	Storm Grate/Utility Hazard?	N/A	
	Total Cost: \$	200.00	Obstruction Type			Storm Grate/Utility Type		
				N/A			N/A
