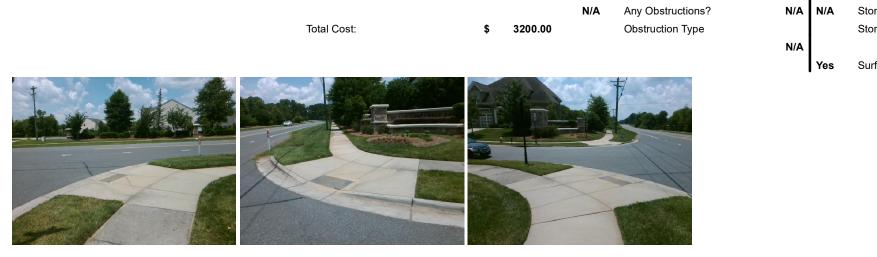
Intersection ID: 47966 Main Street: MESA_VERDE_RD			Cross Street: TOM_SHORT_RD					Location:	NE
ADA ID: 2C89B005CA09 Ramp Type: PerpDiag		Initial Pass/Fail: Fail Overall Compliance: No				o Severity Score:	21.25		
Codes/Mitigation Info/Possible Solution				Field Measurements/Component Compliance					
		Possible Solutions:		Compliance Description			Data Compliance Description		
		Remove & Replace Curb Ramp W	/ith	N/A	Ramp Length (in)	149.0	Yes	Ramp Slope (%)	7.8
		Two New Directional Ramps or Equivalent.		No	Ramp Width (in)	46.0	No	Ramp XSlope (%)	5.2
				N/A	Flare Type LT	N/A	N/A	Flare Type RT	N/A

-		N/A	Flare Slope LT (%)	N/A	N/A	Flare Slope RT (%)	N/A
				N/A	Flare Traversable LT?	N/A	N/A	Flare Traversable RT?	N/A
	Charles and the			N/A	Landing Length (in)	N/A	N/A	DWS Provided?	N/A
		Surveyor Notes:		N/A	Landing Width (in)	N/A	N/A	DWS Contrast?	N/A
		N/A		N/A	Landing Slope (%)	N/A	N/A	DWS Length (in)	N/A
		N/A		N/A	Landing X Slope (%)	N/A	N/A	DWS Full Width?	N/A
6 6 6.				N/A	Landing Curb? (Y/N)	N/A	N/A	DWS Offset (in)	N/A
	States and the second states			N/A	Shared Landing?	N/A		DWG Oliset (III)	11/4
		PROW/ADA:		N/A	Gutter Ponding?	N/A	N/A	Gutter Slope (%)	N/A
					U U	N/A			
		Not Found, R304.5.1, R304.5.3		N/A	Gutter Lip Ht (in)		N/A	Gutter X Slope (%)	N/A
			1	N/A	Painted X Walk1?	No	N/A	Painted X Walk2?	No
					X Walk 1 Direction	To NW		X Walk 2 Direction	To SW
			I	N/A	X Walk 1 Width (in)	N/A	N/A	X Walk 2 Width (in)	N/A
Street 1 Name	TOM SHORT RD				X Walk 1 Slope (%)	4.1		X Walk 2 Slope (%)	0.4

Stop Condition-Street 2	None				X Walk 1 X Slope (%)	2.1		X Walk 2 X Slope (%)	2.8
Street 2 Name	MESA VERDE RD		I	N/A	Ramp inside XWalk1?	N/A	N/A	Ramp inside XWalk2?	N/A
Stop Condition-Street 1	StopSign				Road Slope (%)	3.3	N/A	Clear Space?	N/A
					Road X Slope (%)	2.8	N/A	Clear Space to XWalk (in)	N/A
				N/A	Any Obstructions?	N/A	N/A	Storm Grate/Utility Hazard?	N/A
		Total Cost: \$ 32	200.00		Obstruction Type			Storm Grate/Utility Type	
						N/A			N/A
