Access Compliance Report

Public Rights-of-Way

(Curb Ramps)

Intersection ID: 27418	Main Street: BALLANTYNE COMMONS PY	Cross Street: BALLANTYNE TRACE CT	Location: SE
ADA ID: 2CAAC9665104	Ramp Type: Perp	Initial Pass/Fail: Fail	Overall Compliance: No
Severity Score: 22.5			
Codes/Mitigation Info/Possible Solution		Field Measurements/Component Compliance

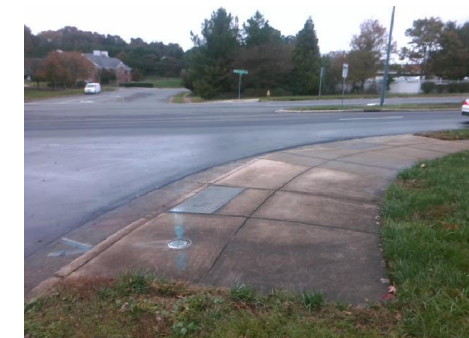
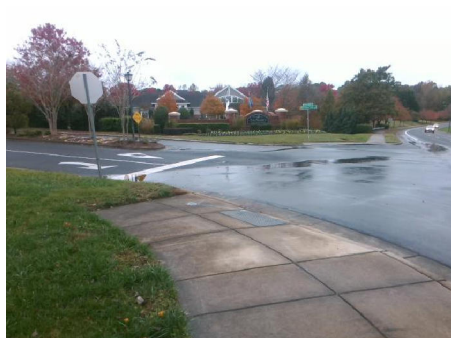
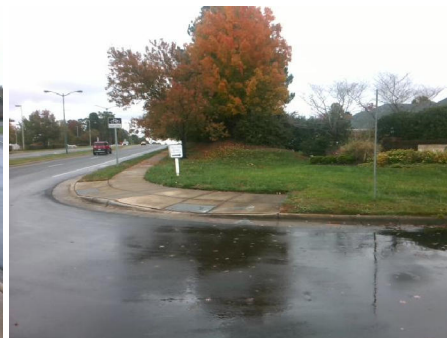
Not Found, R304.5.1, R304.2.2, R304.5.3

Compliance	Description	Data	Compliance	Description	Data
N/A	Ramp Length (in)	108.0	No	Ramp Slope (%)	10.2
No	Ramp Width (in)	38.0	No	Ramp XSlope (%)	2.1
N/A	Flare Type LT	N/A	N/A	Flare Type RT	N/A
N/A	Flare Slope LT (%)	N/A	N/A	Flare Slope RT (%)	N/A
N/A	Flare Traversable LT?	N/A	N/A	Flare Traversable RT?	N/A
N/A	Landing Length (in)	N/A	N/A	DWS Provided?	N/A
N/A	Landing Width (in)	N/A	N/A	DWS Contrast?	N/A
N/A	Landing Slope (%)	N/A	N/A	DWS Length (in)	N/A
N/A	Landing X Slope (%)	N/A	N/A	DWS Full Width?	N/A
N/A	Landing Curb? (Y/N)	N/A	N/A	DWS Offset (in)	N/A
N/A	Shared Landing?	N/A			
N/A	Gutter Ponding?	N/A	N/A	Gutter Slope (%)	N/A
N/A	Gutter Lip Ht (in)	N/A	N/A	Gutter X Slope (%)	N/A
N/A	Painted X Walk1?	No	N/A	Painted X Walk2?	N/A
	X Walk 1 Direction	To SW		X Walk 2 Direction	N/A
N/A	X Walk 1 Width (in)	N/A	N/A	X Walk 2 Width (in)	N/A
	X Walk 1 Slope (%)	3.7		X Walk 2 Slope (%)	N/A
	X Walk 1 X Slope (%)	0.0		X Walk 2 X Slope (%)	N/A

N/A	Ramp inside XWalk1?	N/A	N/A	Ramp inside XWalk2?	N/A
	Road Slope (%)	N/A	N/A	Clear Space?	N/A
	Road X Slope (%)	N/A	N/A	Clear Space to XWalk (in)	N/A
N/A	Any Obstructions?	N/A	N/A	Storm Grate/Utility Hazard?	N/A
	Obstruction Type			Storm Grate/Utility Type	
		N/A			N/A
			Yes	Surface Condition? (G/P)	Good

Possible Solutions:

Remove & Replace Entire Ramp.
