Access Compliance Report

Public Rights-of-Way

(Curb Ramps)

Intersection ID: 11176	Main Street: AVENSONG_CROSSING_DR	Cross Street: CELLO_CT	Location: NW
ADA ID: 2CACCA09357D	Ramp Type: BlendTrans1	Initial Pass/Fail: Fail	Overall Compliance: No
Severity Score: 10			
Codes/Mitigation Info/Possible Solution		Field Measurements/Component Compliance

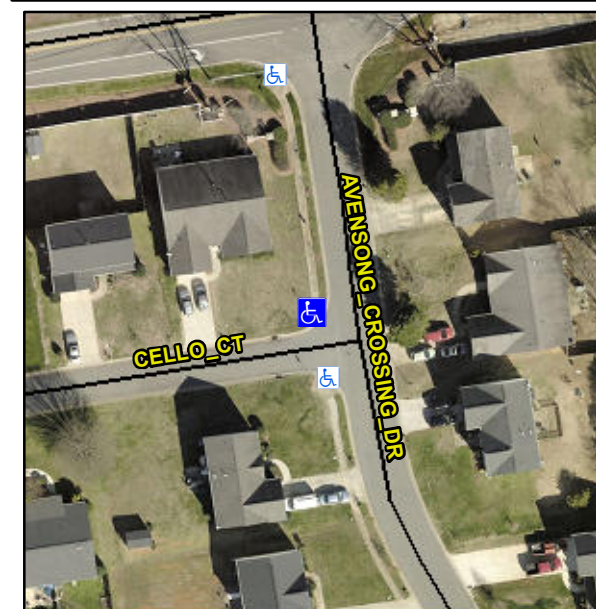
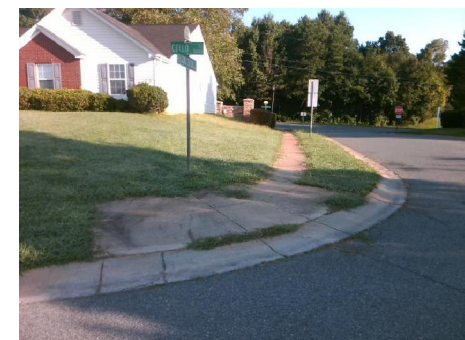
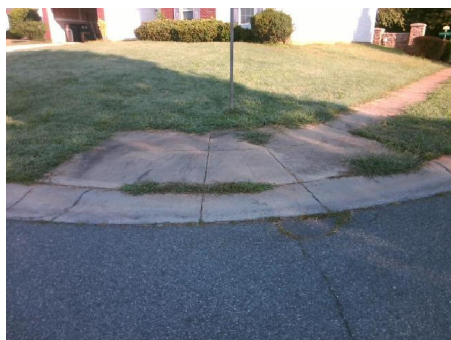
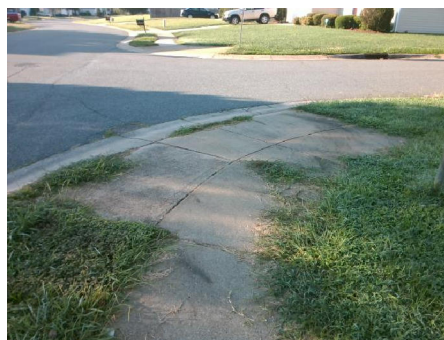
NO LT SW

Not Found, R304.5.1, R304.5.3

Compliance	Description	Data	Compliance	Description	Data
N/A	Ramp Length (in)	45.0	Yes	BlendTrans Slope (%)	4.0
No	Ramp Width (in)	38.0	No	BlendTrans XSlope (%)	2.2
N/A	Flare Type LT	N/A	N/A	Flare Type RT	N/A
N/A	Flare Slope LT (%)	N/A	N/A	Flare Slope RT (%)	N/A
N/A	Flare Traversable LT?	N/A	N/A	Flare Traversable RT?	N/A
N/A	Landing Length (in)	N/A	N/A	DWS Provided?	N/A
N/A	Landing Width (in)	N/A	N/A	DWS Contrast?	N/A
N/A	Landing Slope (%)	N/A	N/A	DWS Length (in)	N/A
N/A	Landing X Slope (%)	N/A	N/A	DWS Full Width?	N/A
N/A	Landing Curb? (Y/N)	N/A	N/A	DWS Offset (in)	N/A
N/A	Shared Landing?	N/A			
N/A	Gutter Ponding?	N/A	N/A	Gutter Slope (%)	N/A
N/A	Gutter Lip Ht (in)	0.5	N/A	Gutter X Slope (%)	N/A
N/A	Painted X Walk1?	No	N/A	Painted X Walk2?	N/A
	X Walk 1 Direction	To S		X Walk 2 Direction	N/A
	X Walk 1 Width (in)	N/A		X Walk 2 Width (in)	N/A
	X Walk 1 Slope (%)	1.4		X Walk 2 Slope (%)	N/A
	X Walk 1 X Slope (%)	1.4		X Walk 2 X Slope (%)	N/A

N/A	Ramp inside XWalk1?	N/A	N/A	Ramp inside XWalk2?	N/A
	Road Slope (%)	1.4		Clear Space?	N/A
	Road X Slope (%)	1.4	N/A	Clear Space to XWalk (in)	N/A
N/A	Any Obstructions?	N/A	N/A	Storm Grate/Utility Hazard?	N/A
	Obstruction Type			Storm Grate/Utility Type	
		N/A			N/A
			Yes	Surface Condition? (G/P)	Good
			No	Curb Slope (%)	11.3

Possible Solutions:

Remove & Replace Curb Ramp With Two New Directional Ramps or Equivalent.

Total Cost: \$ 3200.00
