Access Compliance Report

Public Rights-of-Way

(Curb Ramps)

| Intersection ID: 1001741 | Main Street: FLAT_RIVER_DR | Cross Street: OVERLAND_PARK_LN | Location: W |

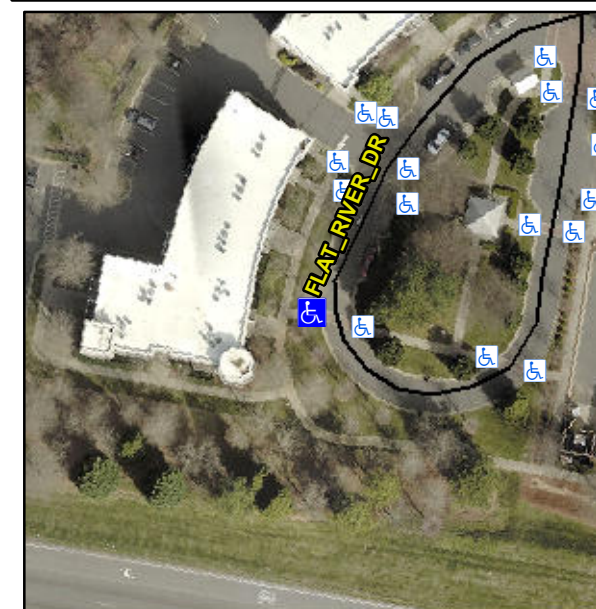
| ADA ID: 2CAD5649D082 | Ramp Type: Perp | Initial Pass/Fail: Fail | Overall Compliance: No |
| Severity Score: 12.5 | | | |

R304.2.2

| Compliance | Description | Data | Compliance | Description | Data |
|---|---|---|---|---|---|
| N/A | Ramp Length (in) | 59.5 | No | Ramp Slope (%) | 10.1 |

Remove & Replace Entire Ramp.

\$ 1850.00
