# Access Compliance Report

## Public Rights-of-Way

### (Curb Ramps)

Intersection ID: 52613	Main Street: GRAHAM RIDGE DR	Cross Street: HERITAGE POND DR	Location: N
ADA ID: 2CB02422D430	Ramp Type: Directional1	Initial Pass/Fail: Pass	Overall Compliance: No
		Severity Score: 0

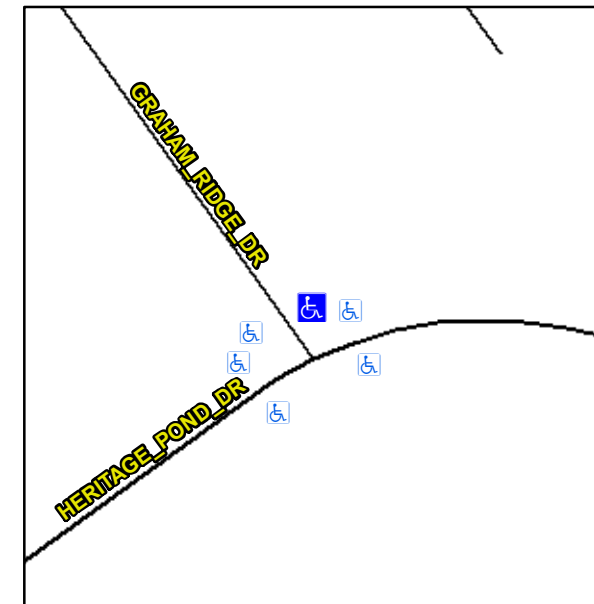
Compliance	Description	Data	Compliance	Description	Data
N/A	Ramp Length (in)	103.0	Yes	Grade Break?	Yes
Yes	Ramp Width (in)	75.5	Yes	Grade Break Slope (%)	4.6
Yes	Ramp Slope (%)	7.3	Yes	Grade Break XSlope (%)	1.1
Yes	Ramp XSlope (%)	1.2			
Yes	Flare Type LT	N/A	Yes	Flare Type RT	N/A
N/A	Flare Slope LT (%)	N/A	N/A	Flare Slope RT (%)	N/A
N/A	Flare Traversable LT?	No	N/A	Flare Traversable RT?	No
Yes	Landing Length (in)	69.5	Yes	DWS Provided?	Yes
Yes	Landing Width (in)	72.5	Yes	DWS Contrast?	Yes
No	Landing Slope (%)	2.8	Yes	DWS Length (in)	24.0
Yes	Landing X Slope (%)	0.8	Yes	DWS Full Width?	Yes
N/A	Landing Curb? (Y/N)	N/A	Yes	DWS Offset LT (in)	32.0
N/A	Shared Landing?	No	Yes	DWS Offset RT (in)	1.0
Yes	Gutter Ponding?	No	Yes	Gutter Slope (%)	1.6
Yes	Gutter Lip Ht (in)	0.0	Yes	Gutter X Slope (%)	0.9
N/A	Painted X Walk1?	Yes		Road Slope (%)	0.6
	X Walk 1 Direction	To SW		Road X Slope (%)	0.5
	X Walk 1 Width (in)	70.5		Clear Space?	Yes

X Walk 1 Slope (%)	0.6	N/A	Clear Space to XWalk (in)	N/A
	X Walk 1 X Slope (%)	0.5	Yes	Storm Grate/Utility Hazard?	No
Yes	Ramp inside XWalk1?	Yes		Storm Grate/Utility Type	
Yes	Any Obstructions?	No			N/A
	Obstruction Type		Yes	Surface Condition? (G/P)	Good
			N/A	Curb Slope (%)	N/A

Possible Solutions:

**Remove & Replace Landing.**

**R304.2.2-Perp, R304.3.2-Para**
