Access Compliance Report

Public Rights-of-Way

(Curb Ramps)

Intersection ID: 17113	Main Street: STERLING_RD	Cross Street: WESTFIELD_RD	Location: SW
ADA ID: 2CC091BB4AFB	Ramp Type: Directional1	Initial Pass/Fail: Fail	Overall Compliance: No
Severity Score: 13.75			
Codes/Mitigation Info/Possible Solution		Field Measurements/Component Compliance

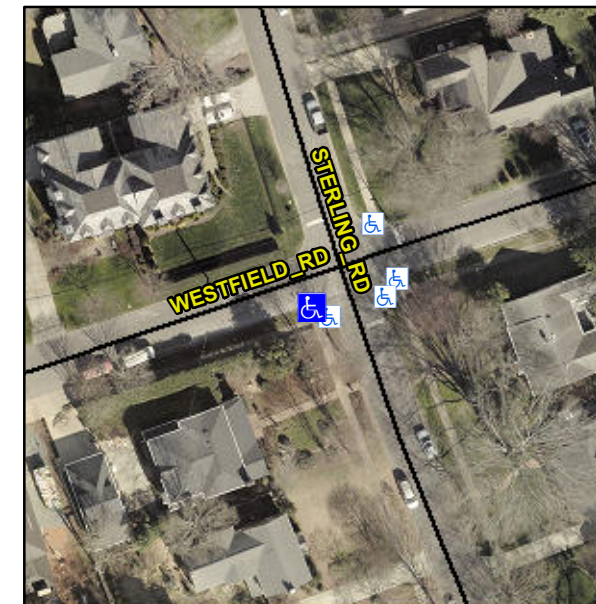
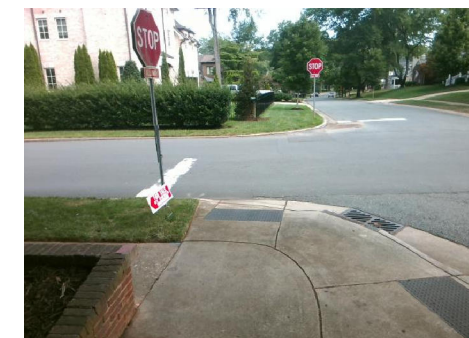
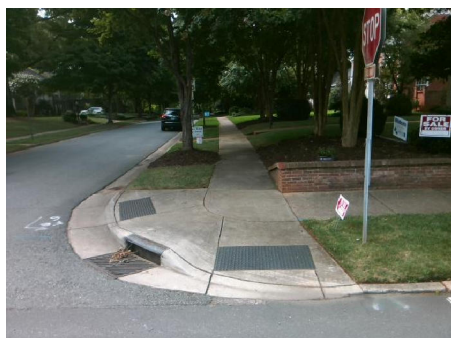
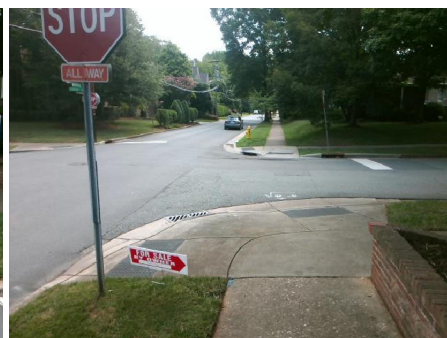
R304.2.2, R304.5.3

Compliance	Description	Data	Compliance	Description	Data
N/A	Ramp Length (in)	66.0	N/A	Grade Break?	N/A
Yes	Ramp Width (in)	48.0	N/A	Grade Break Slope (%)	0.0
No	Ramp Slope (%)	8.6	N/A	Grade Break XSlope (%)	0.0
No	Ramp XSlope (%)	4.1			
N/A	Flare Type LT	N/A	N/A	Flare Type RT	N/A
N/A	Flare Slope LT (%)	N/A	N/A	Flare Slope RT (%)	0.0
N/A	Flare Traversable LT?	N/A	N/A	Flare Traversable RT?	N/A
N/A	Landing Length (in)	0.0	N/A	DWS Provided?	N/A
N/A	Landing Width (in)	0.0	N/A	DWS Contrast?	N/A
N/A	Landing Slope (%)	0.0	N/A	DWS Length (in)	N/A
N/A	Landing X Slope (%)	0.0	N/A	DWS Full Width?	N/A
N/A	Landing Curb? (Y/N)	N/A	N/A	DWS Offset LT (in)	N/A
N/A	Shared Landing?	N/A	N/A	DWS Offset RT (in)	N/A
N/A	Gutter Ponding?	0.0	N/A	Gutter Slope (%)	N/A
N/A	Gutter Lip Ht (in)	0.0	N/A	Gutter X Slope (%)	N/A
N/A	Painted X Walk1?	No		Road Slope (%)	2.8
	X Walk 1 Direction	To NW		Road X Slope (%)	2.7
	X Walk 1 Width (in)	N/A		Clear Space?	N/A

X Walk 1 Slope (%)	2.8	N/A	Clear Space to XWalk (in)	N/A
	X Walk 1 X Slope (%)	2.7	N/A	Storm Grate/Utility Hazard?	N/A
N/A	Ramp inside XWalk1?	N/A		Storm Grate/Utility Type	
N/A	Any Obstructions?	N/A			N/A
	Obstruction Type		Yes	Surface Condition? (G/P)	Good
			N/A	Curb Slope (%)	5.5

Possible Solutions:

Remove & Replace Entire Ramp.
