## Access Compliance Report Public Rights-of-Way (Curb Ramps)

Intersection ID: 29546Main Street:CROSS\_POINT\_CRCross Street:STONEHAM\_CTLocation:NWADA ID: 2CC544A24E21Ramp Type:BlendTrans1Initial Pass/Fail:FailOverall Compliance:NoSeverity Score:25

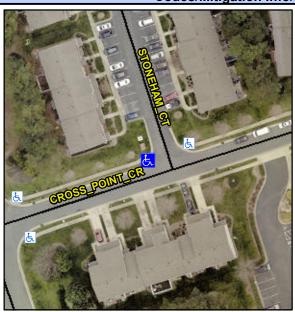
Not Found, R304.5.3

Compliance Description		Data	Comp	liance Description	Data
N/A	Ramp Length (in)	48.0	Yes	BlendTrans Slope (%)	3.0
Yes	Ramp Width (in)	54.0	No	BlendTrans XSlope (%)	9.4
N/A	Flare Type LT	N/A	N/A	Flare Type RT	N/A
N/A	Flare Slope LT (%)	N/A	N/A	Flare Slope RT (%)	N/A
N/A	Flare Traversable LT?	No	N/A	Flare Traversable RT?	No
N/A	Landing Length (in)	N/A	N/A	DWS Provided?	N/A
N/A	Landing Width (in)	N/A	N/A	DWS Contrast?	N/A
N/A	Landing Slope (%)	N/A	N/A	DWS Length (in)	N/A
N/A	Landing X Slope (%)	N/A	N/A	DWS Full Width?	N/A
N/A	Landing Curb? (Y/N)	N/A	N/A	DWS Offset (in)	N/A
N/A	Shared Landing?	N/A			
N/A	Gutter Ponding?	N/A	N/A	Gutter Slope (%)	N/A
N/A	Gutter Lip Ht (in)	N/A	N/A	Gutter X Slope (%)	N/A
N/A	Painted X Walk1?	No	N/A	Painted X Walk2?	No
	X Walk 1 Direction	To S		X Walk 2 Direction	To E
	X Walk 1 Width (in)	N/A		X Walk 2 Width (in)	N/A
	X Walk 1 Slope (%)	6.8		X Walk 2 Slope (%)	3.0
	X Walk 1 X Slope (%)	3.0		X Walk 2 X Slope (%)	3.5

N/A	Ramp inside XWalk1?	N/A	N/A	Ramp inside XWalk2?	N/A
	Road Slope (%)	5.6		Clear Space?	N/A
	Road X Slope (%)	2.3	N/A	Clear Space to XWalk (in)	N/A
N/A	Any Obstructions?	N/A	N/A	Storm Grate/Utility Hazard?	N/A
	Obstruction Type			Storm Grate/Utility Type	
		N/A			N/A
			Yes	Surface Condition? (G/P)	Good

Remove & Replace Curb Ramp With
Two New Directional Ramps or
Equivalent.

Total Cost: \$ 3200.00
