# Access Compliance Report

## Public Rights-of-Way

### (Curb Ramps)

Intersection ID: 31221	Main Street: MANGLA_DR	Cross Street: OROVILLE_CT	Location: S
ADA ID: 2CC7EF0206A4	Ramp Type: PerpDiag	Initial Pass/Fail: Fail	Overall Compliance: No
			Severity Score: 33.75

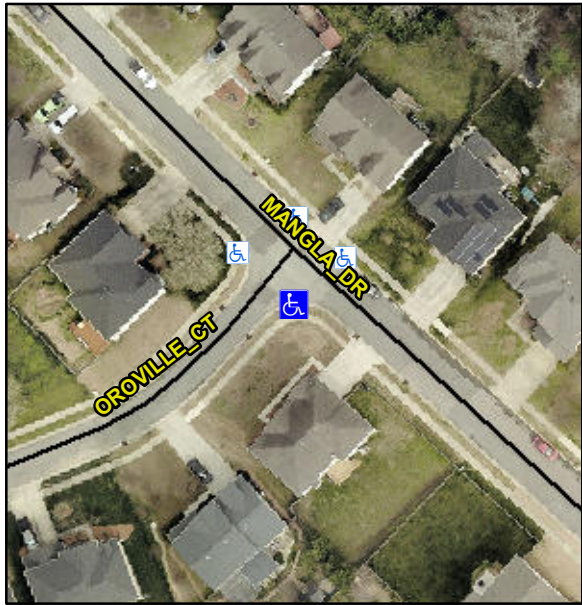
Possible Solutions:		Compliance	Description	Data	Compliance	Description	Data
	Remove & Replace Curb Ramp With Two New Directional Ramps or Equivalent.		N/A	Ramp Length (in)	48.0	No	Ramp Slope (%)	15.5
			No	Ramp Width (in)	38.0	Yes	Ramp XSlope (%)	1.4
			N/A	Flare Type LT	N/A	N/A	Flare Type RT	N/A
			N/A	Flare Slope LT (%)	N/A	N/A	Flare Slope RT (%)	N/A
			N/A	Flare Traversable LT?	N/A	N/A	Flare Traversable RT?	N/A
			N/A	Landing Length (in)	N/A	N/A	DWS Provided?	N/A
			N/A	Landing Width (in)	N/A	N/A	DWS Contrast?	N/A
			N/A	Landing Slope (%)	N/A	N/A	DWS Length (in)	N/A
			N/A	Landing X Slope (%)	N/A	N/A	DWS Full Width?	N/A
Surveyor Notes:		N/A	Landing Curb? (Y/N)	N/A	N/A	DWS Offset (in)	N/A	N/A
PROW/ADA:		N/A	Shared Landing?	N/A				
R304.5.1, R304.2.2		N/A	Gutter Ponding?	N/A	N/A	Gutter Slope (%)	N/A	N/A
		N/A	Gutter Lip Ht (in)	N/A	N/A	Gutter X Slope (%)	N/A	N/A

N/A	Painted X Walk1?	No	N/A	Painted X Walk2?	No	No
			X Walk 1 Direction	To NE		X Walk 2 Direction	To NW	
		N/A	X Walk 1 Width (in)	N/A	N/A	X Walk 2 Width (in)	N/A	N/A
			X Walk 1 Slope (%)	1.1		X Walk 2 Slope (%)	4.1	
			X Walk 1 X Slope (%)	3.6		X Walk 2 X Slope (%)	0.7	
Street 1 Name		OROVILLE CT	N/A	Ramp inside XWalk1?	N/A	N/A	Ramp inside XWalk2?	N/A
Stop Condition-Street 2		None		Road Slope (%)	1.7	N/A	Clear Space?	N/A
Street 2 Name		MANGLA DR		Road X Slope (%)	4.3	N/A	Clear Space to XWalk (in)	N/A
Stop Condition-Street 1		StopSign	N/A	Any Obstructions?	N/A	N/A	Storm Grate/Utility Hazard?	N/A
				Obstruction Type			Storm Grate/Utility Type	
					N/A			N/A
						Yes	Surface Condition? (G/P)	Good
Total Cost:		\$ 3200.00
