Access Compliance Report

Public Rights-of-Way

(Curb Ramps)

Intersection ID: 29180	Main Street: BOXELDER_LN	Cross Street: BIG_LEAF_DR	Location: SE
ADA ID: 2CCAC85FDE4F	Ramp Type: BlendTrans1	Initial Pass/Fail: Pass	Overall Compliance: No
		Severity Score: 15

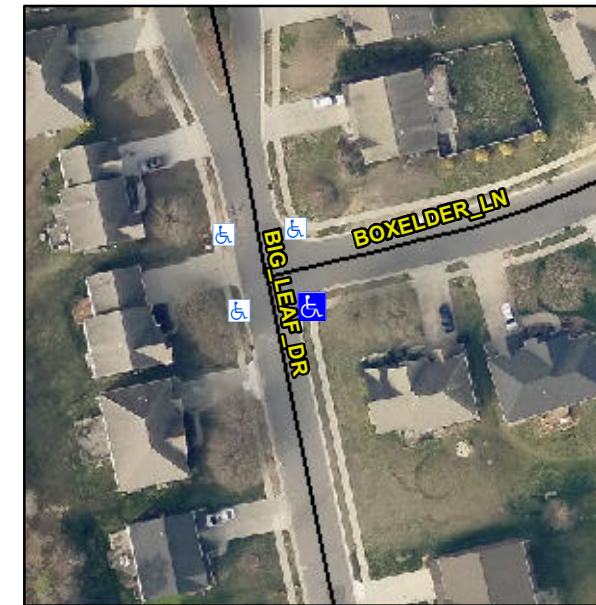
Not Found, R304.2.1, R304.2.2-Perp, R304.3.2-Para, R305, R304.5.4

Compliance	Description	Data	Compliance	Description	Data
N/A	Ramp Length (in)	49.0	Yes	BlendTrans Slope (%)	3.3
Yes	Ramp Width (in)	55.0	Yes	BlendTrans XSlope (%)	0.3
N/A	Flare Type LT	Sloped	N/A	Flare Type RT	Sloped
N/A	Flare Slope LT (%)	0.3	N/A	Flare Slope RT (%)	1.9
N/A	Flare Traversable LT?	No	N/A	Flare Traversable RT?	No
No	Landing Length (in)	45.5	No	DWS Provided?	No
Yes	Landing Width (in)	75.0	N/A	DWS Contrast?	No
No	Landing Slope (%)	3.9	N/A	DWS Length (in)	N/A
Yes	Landing X Slope (%)	1.8	N/A	DWS Full Width?	No
N/A	Landing Curb? (Y/N)	No	N/A	DWS Offset (in)	N/A
N/A	Shared Landing?	No			
Yes	Gutter Ponding?	No	No	Gutter Slope (%)	5.9
Yes	Gutter Lip Ht (in)	0.0	Yes	Gutter X Slope (%)	0.6
N/A	Painted X Walk1?	No	N/A	Painted X Walk2?	No
	X Walk 1 Direction	To N		X Walk 2 Direction	To W
	X Walk 1 Width (in)	N/A		X Walk 2 Width (in)	N/A
	X Walk 1 Slope (%)	3.5		X Walk 2 Slope (%)	6.1
	X Walk 1 X Slope (%)	4.0		X Walk 2 X Slope (%)	2.3

N/A	Ramp inside XWalk1?	N/A	N/A	Ramp inside XWalk2?	N/A
	Road Slope (%)	0.5		Clear Space?	Yes
	Road X Slope (%)	6.2	N/A	Clear Space to XWalk (in)	N/A
Yes	Any Obstructions?	No	Yes	Storm Grate/Utility Hazard?	No
	Obstruction Type			Storm Grate/Utility Type	
		N/A			N/A
			Yes	Surface Condition? (G/P)	Good
			No	Curb Slope (%)	11.8

Remove & Replace Curb Ramp With Two New Directional Ramps or Equivalent. Remove & Replace Gutter.
