Access Compliance Report

Public Rights-of-Way (Curb Ramps)

Intersection ID: N/A	Main Street: STATESVILLE_AV	Cross Street: OLIVER_ST	Location: NE
ADA ID: 2CD3A30726F7	Ramp Type: Directional1	Initial Pass/Fail: Fail	Overall Compliance: No
		Severity Score: 12.5

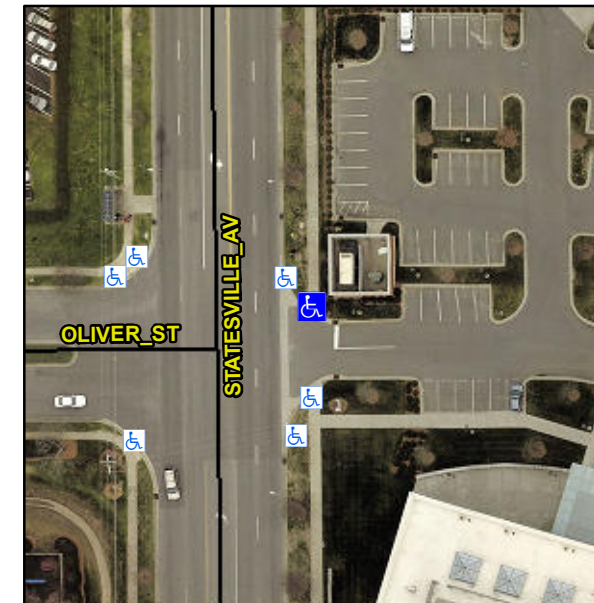
Compliance	Description	Data	Compliance	Description	Data
N/A	Ramp Length (in)	103.0	N/A	Grade Break?	N/A
Yes	Ramp Width (in)	72.0	N/A	Grade Break Slope (%)	0.0
Yes	Ramp Slope (%)	2.3	N/A	Grade Break XSlope (%)	0.0
No	Ramp XSlope (%)	6.4			
N/A	Flare Type LT	N/A	N/A	Flare Type RT	N/A
N/A	Flare Slope LT (%)	N/A	N/A	Flare Slope RT (%)	0.0
N/A	Flare Traversable LT?	N/A	N/A	Flare Traversable RT?	N/A
N/A	Landing Length (in)	0.0	N/A	DWS Provided?	N/A
N/A	Landing Width (in)	0.0	N/A	DWS Contrast?	N/A
N/A	Landing Slope (%)	0.0	N/A	DWS Length (in)	N/A
N/A	Landing X Slope (%)	0.0	N/A	DWS Full Width?	N/A
N/A	Landing Curb? (Y/N)	N/A	N/A	DWS Offset LT (in)	N/A
N/A	Shared Landing?	N/A	N/A	DWS Offset RT (in)	N/A
N/A	Gutter Ponding?	0.0	N/A	Gutter Slope (%)	N/A
N/A	Gutter Lip Ht (in)	0.0	N/A	Gutter X Slope (%)	N/A
N/A	Painted X Walk1?	No		Road Slope (%)	1.7
	X Walk 1 Direction	To S		Road X Slope (%)	6.1
	X Walk 1 Width (in)	N/A		Clear Space?	N/A

X Walk 1 Slope (%)	1.7	N/A	Clear Space to XWalk (in)	N/A
	X Walk 1 X Slope (%)	6.1	N/A	Storm Grate/Utility Hazard?	N/A
N/A	Ramp inside XWalk1?	N/A		Storm Grate/Utility Type	
N/A	Any Obstructions?	N/A			N/A
	Obstruction Type		Yes	Surface Condition? (G/P)	Good
			N/A	Curb Slope (%)	9.0

Remove & Replace Entire Ramp.

R304.5.3

\$ 1600.00
