# Access Compliance Report

## Public Rights-of-Way

### (Curb Ramps)

Intersection ID: N/A	Main Street: ELGIN_MOOR_RD	Cross Street: DOUGLAS_PALACE_CT	Location: SE
ADA ID: 2CDF9BFCE096	Ramp Type: Perp	Initial Pass/Fail: Fail	Overall Compliance: No
		Severity Score: 12.5

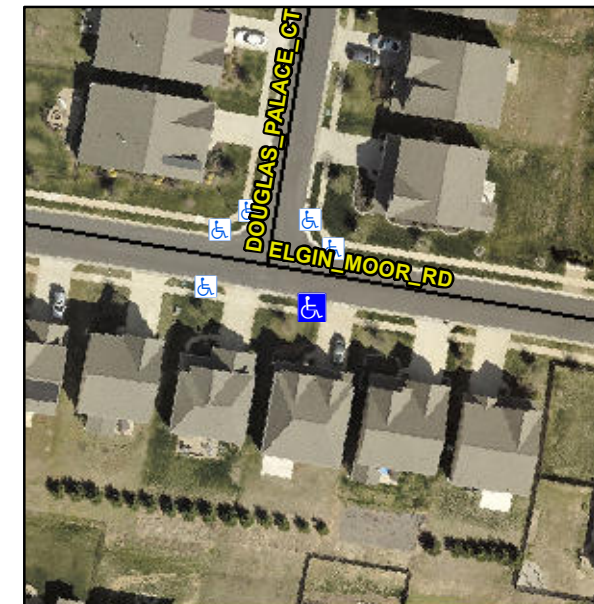
**Not Found, R304.2.2**

Compliance	Description	Data	Compliance	Description	Data
N/A	Ramp Length (in)	48.0	No	Ramp Slope (%)	9.0
Yes	Ramp Width (in)	48.0	Yes	Ramp XSlope (%)	1.2
N/A	Flare Type LT	N/A	N/A	Flare Type RT	N/A
N/A	Flare Slope LT (%)	N/A	N/A	Flare Slope RT (%)	N/A
N/A	Flare Traversable LT?	N/A	N/A	Flare Traversable RT?	N/A
N/A	Landing Length (in)	N/A	N/A	DWS Provided?	N/A
N/A	Landing Width (in)	N/A	N/A	DWS Contrast?	N/A
N/A	Landing Slope (%)	N/A	N/A	DWS Length (in)	N/A
N/A	Landing X Slope (%)	N/A	N/A	DWS Full Width?	N/A
N/A	Landing Curb? (Y/N)	N/A	N/A	DWS Offset (in)	N/A
N/A	Shared Landing?	N/A			
N/A	Gutter Ponding?	N/A	N/A	Gutter Slope (%)	N/A
N/A	Gutter Lip Ht (in)	1.0	N/A	Gutter X Slope (%)	N/A
N/A	Painted X Walk1?	No	N/A	Painted X Walk2?	N/A
	X Walk 1 Direction	To NE		X Walk 2 Direction	N/A
N/A	X Walk 1 Width (in)	N/A	N/A	X Walk 2 Width (in)	N/A
	X Walk 1 Slope (%)	2.2		X Walk 2 Slope (%)	N/A
	X Walk 1 X Slope (%)	1.7		X Walk 2 X Slope (%)	N/A

N/A	Ramp inside XWalk1?	N/A	N/A	Ramp inside XWalk2?	N/A
	Road Slope (%)	N/A	N/A	Clear Space?	N/A
	Road X Slope (%)	N/A	N/A	Clear Space to XWalk (in)	N/A
N/A	Any Obstructions?	N/A	N/A	Storm Grate/Utility Hazard?	N/A
	Obstruction Type			Storm Grate/Utility Type	
		N/A			N/A
			Yes	Surface Condition? (G/P)	Good

Possible Solutions:

**Remove & Replace Entire Ramp.**

Total Cost: \$ 1850.00
