Access Compliance Report Public Rights-of-Way (Curb Ramps)

Intersection ID: 46190 Main Street: YAUPON_RD Cross Street: LUSTRE_RD Location: SE **Overall Compliance: No**

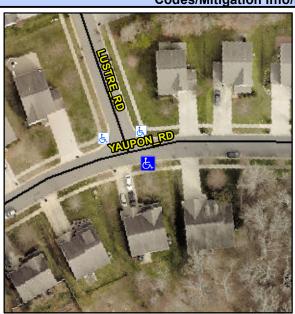
Ramp Type: Perp

Possible Solutions:	9		
Remove & Replace Entire Ramp.			
Remove & Replace Gutter.)		
	ľ		
	ı		
	ı		
	,		
Surveyor Notes:	•		
N/A	,		
	•		
	ı		
	ı		
PROW/ADA:	•		
Not Found, R305.2, R304.5.4	١		
, ,	ı		
	ı

Field Measurements/Component Compliance								
Comp	oliance Description	Data	Comp	liance Description	Data			
N/A	Ramp Length (in)	70.5	Yes	Ramp Slope (%)	7.7			
Yes	Ramp Width (in)	48.0	Yes	Ramp XSlope (%)	1.1			
N/A	Flare Type LT	Sloped	N/A	Flare Type RT	N/A			
N/A	Flare Slope LT (%)	10.5	N/A	Flare Slope RT (%)	6.5			
N/A	Flare Traversable LT?	No	N/A	Flare Traversable RT?	No			
Yes	Landing Length (in)	48.0	Yes	DWS Provided?	Yes			
Yes	Landing Width (in)	48.0	Yes	DWS Contrast?	Yes			
Yes	Landing Slope (%)	1.8	Yes	DWS Length (in)	24.0			
Yes	Landing X Slope (%)	1.4	Yes	DWS Full Width?	Yes			
N/A	Landing Curb? (Y/N)	No	No	DWS Offset (in)	3.3			
N/A	Shared Landing?	No						
Yes	Gutter Ponding?	No	No	Gutter Slope (%)	7.4			
Yes	Gutter Lip Ht (in)	0.0	Yes	Gutter X Slope (%)	1.6			
N/A	Painted X Walk1?	No	N/A	Painted X Walk2?	N/A			
	X Walk 1 Direction	To N		X Walk 2 Direction	N/A			
N/A	X Walk 1 Width (in)	N/A	N/A	X Walk 2 Width (in)	N/A

X Walk 1 Slope (%)	4.8		X Walk 2 Slope (%)	N/A			
	X Walk 1 X Slope (%)	1.5		X Walk 2 X Slope (%)	N/A			
N/A	Ramp inside XWalk1?	N/A	N/A	Ramp inside XWalk2?	N/A			
	Road Slope (%)	N/A	N/A	Clear Space?	Yes			
	Road X Slope (%)	N/A	N/A	Clear Space to XWalk (in)	N/A			
Yes	Any Obstructions?	No	Yes	Storm Grate/Utility Hazard?	No			
	Obstruction Type			Storm Grate/Utility Type				
		N/A			N/A			
			Yes	Surface Condition? (G/P)	Good			
UPP A 4

Yes
			N/A
			N/A
PROW/ADA:			Yes
Not Found, R305.2, R304.5	5.4		Yes
			N/A
			N/A
			N/A
Total Cost:	\$	2600.00	Yes
