Access Compliance Report

Public Rights-of-Way

(Curb Ramps)

Intersection ID: 52441	Main Street: WOODWARD_AV	Cross Street: BENDING_BIRCH_PL	Location: NE
ADA ID: 2CEAAD191812	Ramp Type: Directional1	Initial Pass/Fail: Fail	Overall Compliance: No
		Severity Score: 12.5

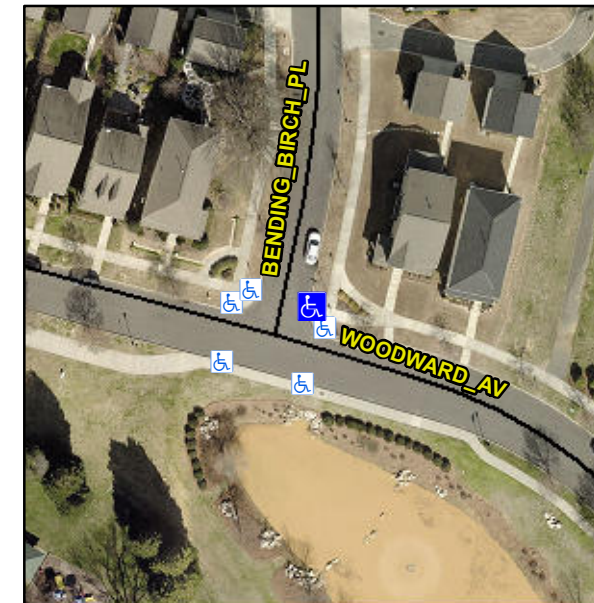
Compliance	Description	Data	Compliance	Description	Data
N/A	Ramp Length (in)	75.0	N/A	Grade Break?	N/A
Yes	Ramp Width (in)	63.5	N/A	Grade Break Slope (%)	0.0
No	Ramp Slope (%)	9.9	N/A	Grade Break XSlope (%)	0.0
Yes	Ramp XSlope (%)	0.8			
N/A	Flare Type LT	N/A	N/A	Flare Type RT	N/A
N/A	Flare Slope LT (%)	N/A	N/A	Flare Slope RT (%)	0.0
N/A	Flare Traversable LT?	N/A	N/A	Flare Traversable RT?	N/A
N/A	Landing Length (in)	0.0	N/A	DWS Provided?	N/A
N/A	Landing Width (in)	0.0	N/A	DWS Contrast?	N/A
N/A	Landing Slope (%)	0.0	N/A	DWS Length (in)	N/A
N/A	Landing X Slope (%)	0.0	N/A	DWS Full Width?	N/A
N/A	Landing Curb? (Y/N)	N/A	N/A	DWS Offset LT (in)	N/A
N/A	Shared Landing?	N/A	N/A	DWS Offset RT (in)	N/A
N/A	Gutter Ponding?	0.0	N/A	Gutter Slope (%)	N/A
N/A	Gutter Lip Ht (in)	0.0	N/A	Gutter X Slope (%)	N/A
N/A	Painted X Walk1?	No		Road Slope (%)	0.6
	X Walk 1 Direction	To W		Road X Slope (%)	1.8
	X Walk 1 Width (in)	N/A		Clear Space?	N/A

X Walk 1 Slope (%)	0.6	N/A	Clear Space to XWalk (in)	N/A
	X Walk 1 X Slope (%)	1.8	N/A	Storm Grate/Utility Hazard?	N/A
N/A	Ramp inside XWalk1?	N/A		Storm Grate/Utility Type	
N/A	Any Obstructions?	N/A			N/A
	Obstruction Type		Yes	Surface Condition? (G/P)	Good
			N/A	Curb Slope (%)	4.2

Remove & Replace Entire Ramp.
