## Access Compliance Report Public Rights-of-Way (Curb Ramps)

Intersection ID: 47283
 Main Street:
 REIDHAVEN\_ST
 Cross Street:
 NETTLETON\_CT
 Location:
 NE

ADA ID: 2CEC111E1749
 Ramp Type:
 PerpDiag
 Initial Pass/Fail:
 Fail
 Overall Compliance:
 No
 Severity Score:
 10

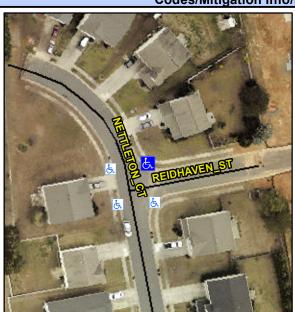
Not Found, R304.5.1, R304.5.3

Field Measurements/Component Compliance					
Compliance Description		Data	Comp	oliance Description	Data
N/A	Ramp Length (in)	51.0	Yes	Ramp Slope (%)	6.5
No	Ramp Width (in)	42.0	No	Ramp XSlope (%)	3.8
N/A	Flare Type LT	N/A	N/A	Flare Type RT	N/A
N/A	Flare Slope LT (%)	N/A	N/A	Flare Slope RT (%)	N/A
N/A	Flare Traversable LT?	N/A	N/A	Flare Traversable RT?	N/A
N/A	Landing Length (in)	N/A	N/A	DWS Provided?	N/A
N/A	Landing Width (in)	N/A	N/A	DWS Contrast?	N/A
N/A	Landing Slope (%)	N/A	N/A	DWS Length (in)	N/A
N/A	Landing X Slope (%)	N/A	N/A	DWS Full Width?	N/A
N/A	Landing Curb? (Y/N)	N/A	N/A	DWS Offset (in)	N/A
N/A	Shared Landing?	N/A			
N/A	Gutter Ponding?	N/A	N/A	Gutter Slope (%)	N/A
N/A	Gutter Lip Ht (in)	N/A	N/A	Gutter X Slope (%)	N/A
N/A	Painted X Walk1?	No	N/A	Painted X Walk2?	No
	X Walk 1 Direction	To W		X Walk 2 Direction	To S
N/A	X Walk 1 Width (in)	N/A	N/A	X Walk 2 Width (in)	N/A
	X Walk 1 Slope (%)	2.4		X Walk 2 Slope (%)	1.8

X Walk 1 X Slope (%)	1.5		X Walk 2 X Slope (%)	0.1
N/A	Ramp inside XWalk1?	N/A	N/A	Ramp inside XWalk2?	N/A
	Road Slope (%)	2.9	N/A	Clear Space?	N/A
	Road X Slope (%)	0.9	N/A	Clear Space to XWalk (in)	N/A
N/A	Any Obstructions?	N/A	N/A	Storm Grate/Utility Hazard?	N/A
	Obstruction Type		l	Storm Grate/Utility Type	
		N/A			N/A
			Yes	Surface Condition? (G/P)	Good

Remove & Replace Curb Ramp With Two New Directional Ramps or Equivalent.
