## Access Compliance Report Public Rights-of-Way (Curb Ramps)

Intersection ID: 44025	on ID: 44025 Main Street: EASTWAY_DR			Cross	Street:	EASTWAY_DR_RA	Location:	NW		
ADA ID: 2CEFF1992683	A ID: 2CEFF1992683 Ramp Type: Perp			Initial Pass/Fail: Pass Overall Compliance: No					o Severity Score:	20.25
Codes/Mitigation Info/Possible Solution					Field Measurements/Component Compliance					
	1	Possible Solutions:			Comp	liance Description	Data Compliance Description			Data
		Remove & Replace E	ntire Ramp.		N/A	Ramp Length (in)	79.0	Yes	Ramp Slope (%)	7.9
No. 19 1 1 1 1 1 1 1 1 1 1 1 1 1 1 1 1 1 1					Yes	Ramp Width (in)	61.5	Yes	Ramp XSlope (%)	4.0
She Blickter III					N/A	Flare Type LT	Sloped	N/A	Flare Type RT	N/A
· · · · · · · · · · · · · · · · · · ·					N/A	Flare Slope LT (%)	0.3	Yes	Flare Slope RT (%)	8.1
and the second of the	// //				N/A	Flare Traversable LT?	Yes	N/A	Flare Traversable RT?	Yes
	d la				No	Landing Length (in)	N/A		DWS Provided?	Yes
		Surveyor Notes:			No	Landing Width (in)	N/A	Yes	DWS Contrast?	Yes

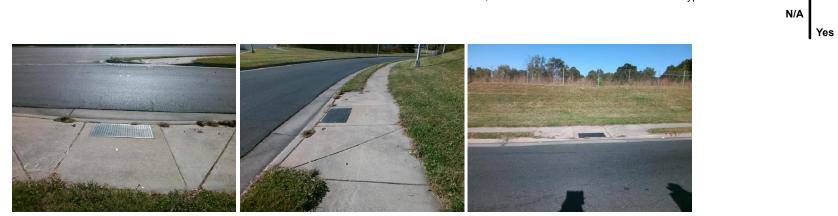
States and the second		N/A			No	Landing Slope (%)	N/A	Yes	DWS Length (in)	26.0
5					No	Landing X Slope (%)	N/A	No	DWS Full Width?	No
and the Al				N/A	Landing Curb? (Y/N)		No	DWS Offset (in)	2.5	
	Sed 1	2			N/A	Shared Landing?	No		2110 01101 (11)	
ALLAN CONTRACTOR		PROW/ADA:			Yes	Gutter Ponding?	No	Yes	Gutter Slope (%)	2.3
a sur	Not Found, R304.2.1,	<b>D204 2 2 D</b>	rn	No	Gutter Lip Ht (in)	0.5	Yes	Gutter X Slope (%)	4.0	
	R304.3.2-Para, R304.4		• •	N/A	Painted X Walk1?	No		Painted X Walk2?	N/A	
	R305.2, R302.7.2	,	',	10/4	X Walk 1 Direction	To SE		X Walk 2 Direction	N/A	
		,			N/A	X Walk 1 Width (in)	N/A	N/A	X Walk 2 Width (in)	N/A
Street 1 Name	EASTWAY DR RA				11/4	X Walk 1 Slope (%)	5.2	11/2	X Walk 2 Slope (%)	N/A
Stop Condition-Street 2	None					X Walk 1 X Slope (%)	5.2 4.0		X Walk 2 X Slope (%)	N/A N/A
Street 2 Name	N/A				N/A	Ramp inside XWalk1?	4.0 N/A	N/A	Ramp inside XWalk2?	N/A
	N/A N/A				N/A		N/A	N/A		Yes

Stop Condition-Street 1	N/A					Road Slope (%)			Clear Space?	
					N.	Road X Slope (%)	N/A	N/A	Clear Space to XWalk (in)	N/A
		<b>T</b> ( ) <b>O</b> (	•		Yes	Any Obstructions?	No	Yes	Storm Grate/Utility Hazard?	No
		Total Cost:	\$ 1	850.00		Obstruction Type			Storm Grate/Utility Type	
							N/A			N/A
