Access Compliance Report

Public Rights-of-Way

(Curb Ramps)

Intersection ID: N/A	Main Street: INVERNESS_BAY_RD	Cross Street: ELGIN_MOOR_RD	Location: NW
ADA ID: 2CF463C0D6DE	Ramp Type: Perp	Initial Pass/Fail: Fail	Overall Compliance: No
		Severity Score: 25

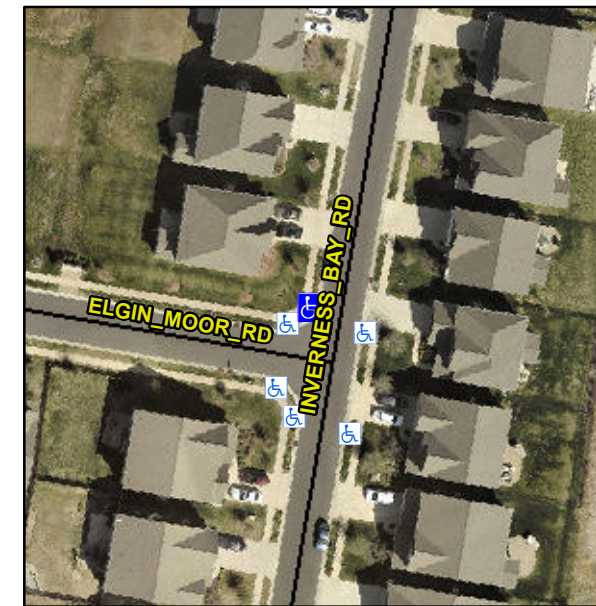
Not Found, R304.2.2, R304.5.3

Compliance	Description	Data	Compliance	Description	Data
N/A	Ramp Length (in)	45.0	No	Ramp Slope (%)	10.5
Yes	Ramp Width (in)	48.0	No	Ramp XSlope (%)	5.1
N/A	Flare Type LT	N/A	N/A	Flare Type RT	N/A
N/A	Flare Slope LT (%)	N/A	N/A	Flare Slope RT (%)	N/A
N/A	Flare Traversable LT?	N/A	N/A	Flare Traversable RT?	N/A
N/A	Landing Length (in)	N/A	N/A	DWS Provided?	N/A
N/A	Landing Width (in)	N/A	N/A	DWS Contrast?	N/A
N/A	Landing Slope (%)	N/A	N/A	DWS Length (in)	N/A
N/A	Landing X Slope (%)	N/A	N/A	DWS Full Width?	N/A
N/A	Landing Curb? (Y/N)	N/A	N/A	DWS Offset (in)	N/A
N/A	Shared Landing?	N/A			
N/A	Gutter Ponding?	N/A	N/A	Gutter Slope (%)	N/A
N/A	Gutter Lip Ht (in)	1.0	N/A	Gutter X Slope (%)	N/A
N/A	Painted X Walk1?	No	N/A	Painted X Walk2?	N/A
	X Walk 1 Direction	To SE		X Walk 2 Direction	N/A
N/A	X Walk 1 Width (in)	N/A	N/A	X Walk 2 Width (in)	N/A
	X Walk 1 Slope (%)	3.0		X Walk 2 Slope (%)	N/A
	X Walk 1 X Slope (%)	3.2		X Walk 2 X Slope (%)	N/A

N/A	Ramp inside XWalk1?	N/A	N/A	Ramp inside XWalk2?	N/A
	Road Slope (%)	N/A	N/A	Clear Space?	N/A
	Road X Slope (%)	N/A	N/A	Clear Space to XWalk (in)	N/A
N/A	Any Obstructions?	N/A	N/A	Storm Grate/Utility Hazard?	N/A
	Obstruction Type			Storm Grate/Utility Type	
		N/A			N/A
			Yes	Surface Condition? (G/P)	Good

Remove & Replace Entire Ramp.
