## Access Compliance Report Public Rights-of-Way (Curb Ramps)

Intersection ID: 7270 Main Street: CANTERWOOD\_DR Cross Street: TOM\_HUNTER\_RD Location: SE

ADA ID: 2CFABB32D3A0 Ramp Type: PerpDiag Initial Pass/Fail: Fail Overall Compliance: No Severity Score: 8.75

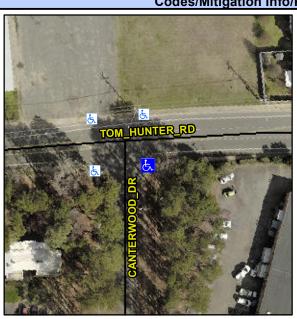
Not Found, R304.5.1

Compliance Description Data Compliance Description Data Yes Ramp Slope (%) N/A Ramp Length (in) 49.0 8.0 Yes Ramp XSlope (%) No Ramp Width (in) 47.5 0.2 N/A N/A Flare Type LT N/A Flare Type RT N/A N/A N/A N/A Flare Slope RT (%) N/A Flare Slope LT (%) N/A Flare Traversable LT? N/A N/A Flare Traversable RT? N/A N/A N/A N/A DWS Provided? N/A Landing Length (in) N/A Landing Width (in) N/A N/A **DWS Contrast?** N/A N/A N/A Landing Slope (%) N/A DWS Length (in) N/A N/A Landing X Slope (%) N/A N/A DWS Full Width? N/A N/A Landing Curb? (Y/N) N/A N/A DWS Offset (in) N/A N/A N/A Shared Landing? N/A Gutter Ponding? N/A N/A Gutter Slope (%) N/A N/A Gutter Lip Ht (in) N/A N/A Gutter X Slope (%) N/A N/A Painted X Walk1? No N/A Painted X Walk2? No X Walk 1 Direction To NE X Walk 2 Direction To SW N/A N/A X Walk 1 Width (in) X Walk 2 Width (in) N/A X Walk 1 Slope (%) 2.9 X Walk 2 Slope (%) 2.5 X Walk 1 X Slope (%) 0.1 X Walk 2 X Slope (%) 1.9 N/A N/A N/A Ramp inside XWalk2? N/A Ramp inside XWalk1? Road Slope (%) 1.4 N/A Clear Space? N/A N/A Road X Slope (%) 3.4 Clear Space to XWalk (in) N/A N/A N/A Any Obstructions? N/A Storm Grate/Utility Hazard? N/A **Obstruction Type** Storm Grate/Utility Type N/A N/A Yes Surface Condition? (G/P) Good

Remove & Replace Curb Ramp With
Two New Directional Ramps or
Equivalent.

Total Cost: \$ 3200.00
