Intersection ID: 30304	Main Street: CHALLENGER_DR	Cross Street: EUROSTAR_DR	Location:	W
ADA ID: 2CFE06EBC243	Ramp Type: PerpDiag	Initial Pass/Fail: Fail	Overall Compliance: No	Severity Score: 25

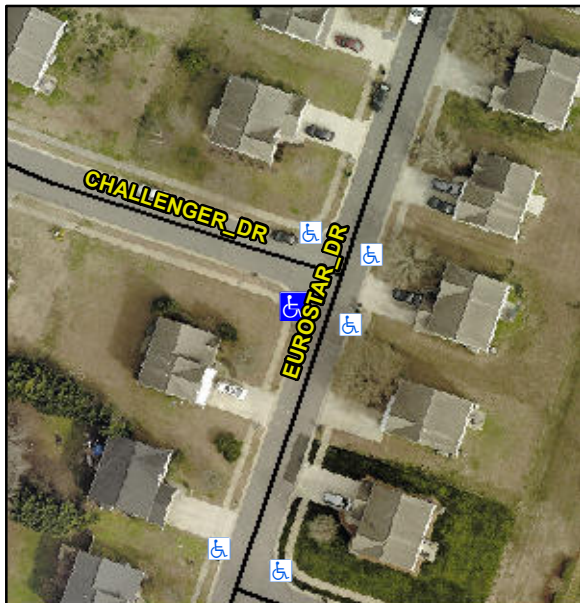
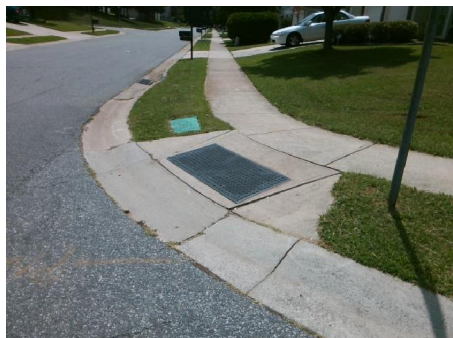
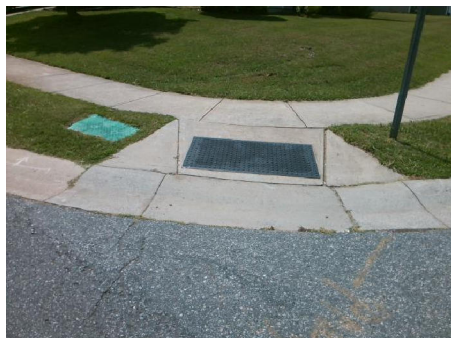
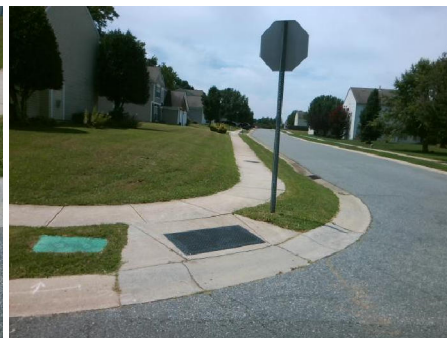
Possible Solutions:			Compliance	Description	Data	Compliance	Description	Data
	Remove & Replace Curb Ramp With Two New Directional Ramps or Equivalent.			N/A	Ramp Length (in)	46.0	No	Ramp Slope (%)	12.2
				Yes	Ramp Width (in)	49.5	Yes	Ramp XSlope (%)	1.3
				N/A	Flare Type LT	N/A	N/A	Flare Type RT	N/A
				N/A	Flare Slope LT (%)	N/A	N/A	Flare Slope RT (%)	N/A
				N/A	Flare Traversable LT?	N/A	N/A	Flare Traversable RT?	N/A
				N/A	Landing Length (in)	N/A	N/A	DWS Provided?	N/A
				N/A	Landing Width (in)	N/A	N/A	DWS Contrast?	N/A
				N/A	Landing Slope (%)	N/A	N/A	DWS Length (in)	N/A
				N/A	Landing X Slope (%)	N/A	N/A	DWS Full Width?	N/A
Surveyor Notes:			N/A	Landing Curb? (Y/N)	N/A	N/A	DWS Offset (in)	N/A	
PROW/ADA:				N/A	Shared Landing?	N/A			
Not Found, R304.2.2				N/A	Gutter Ponding?	N/A	N/A	Gutter Slope (%)	N/A

N/A	Gutter Lip Ht (in)	N/A	N/A	Gutter X Slope (%)	N/A
				N/A	Painted X Walk1?	No	N/A	Painted X Walk2?	No
					X Walk 1 Direction	To S		X Walk 2 Direction	To NE
				N/A	X Walk 1 Width (in)	N/A	N/A	X Walk 2 Width (in)	N/A
					X Walk 1 Slope (%)	5.3		X Walk 2 Slope (%)	0.2
					X Walk 1 X Slope (%)	1.1		X Walk 2 X Slope (%)	2.5
Street 1 Name			EUROSTAR DR	N/A	Ramp inside XWalk1?	N/A	N/A	Ramp inside XWalk2?	N/A
Stop Condition-Street 2			None		Road Slope (%)	1.1	N/A	Clear Space?	N/A
Street 2 Name			CHALLENGER DR		Road X Slope (%)	0.0	N/A	Clear Space to XWalk (in)	N/A
Stop Condition-Street 1			StopSign	N/A	Any Obstructions?	N/A	N/A	Storm Grate/Utility Hazard?	N/A
					Obstruction Type			Storm Grate/Utility Type	
						N/A			N/A
							Yes	Surface Condition? (G/P)	Good
