# Access Compliance Report

## Public Rights-of-Way

### (Curb Ramps)

Intersection ID: 16383	Main Street: E_CAMA_ST	Cross Street: HERIOT_AV	Location: NE
ADA ID: 2D052C515482	Ramp Type: PerpDiag	Initial Pass/Fail: Fail	Overall Compliance: No
		Severity Score: 37.5

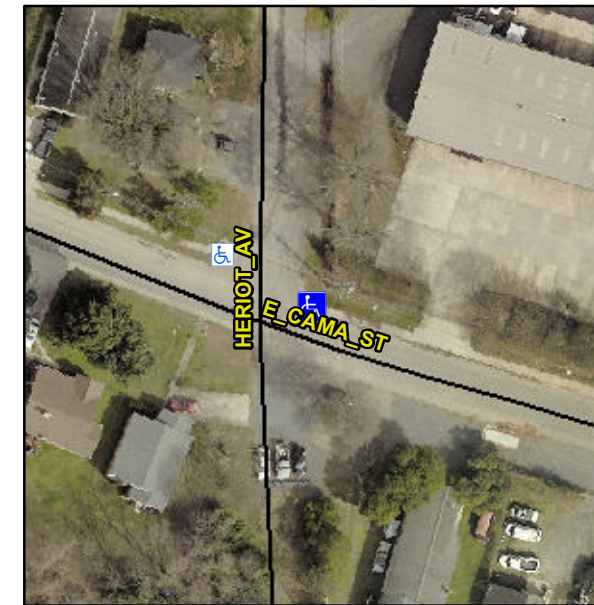
**Not Found, R304.2.2, R304.5.3**

Compliance	Description	Data	Compliance	Description	Data
N/A	Ramp Length (in)	35.0	No	Ramp Slope (%)	13.9
Yes	Ramp Width (in)	48.0	No	Ramp XSlope (%)	5.4
N/A	Flare Type LT	N/A	N/A	Flare Type RT	N/A
N/A	Flare Slope LT (%)	N/A	N/A	Flare Slope RT (%)	N/A
N/A	Flare Traversable LT?	N/A	N/A	Flare Traversable RT?	N/A
N/A	Landing Length (in)	N/A	N/A	DWS Provided?	N/A
N/A	Landing Width (in)	N/A	N/A	DWS Contrast?	N/A
N/A	Landing Slope (%)	N/A	N/A	DWS Length (in)	N/A
N/A	Landing X Slope (%)	N/A	N/A	DWS Full Width?	N/A
N/A	Landing Curb? (Y/N)	N/A	N/A	DWS Offset (in)	N/A
N/A	Shared Landing?	N/A			
N/A	Gutter Ponding?	N/A	N/A	Gutter Slope (%)	N/A
N/A	Gutter Lip Ht (in)	N/A	N/A	Gutter X Slope (%)	N/A
N/A	Painted X Walk1?	No	N/A	Painted X Walk2?	No
	X Walk 1 Direction	To NW		X Walk 2 Direction	To S
N/A	X Walk 1 Width (in)	N/A	N/A	X Walk 2 Width (in)	N/A
	X Walk 1 Slope (%)	2.9		X Walk 2 Slope (%)	1.7
	X Walk 1 X Slope (%)	1.1		X Walk 2 X Slope (%)	2.5

N/A	Ramp inside XWalk1?	N/A	N/A	Ramp inside XWalk2?	N/A
	Road Slope (%)	2.4	N/A	Clear Space?	N/A
	Road X Slope (%)	2.7	N/A	Clear Space to XWalk (in)	N/A
N/A	Any Obstructions?	N/A	N/A	Storm Grate/Utility Hazard?	N/A
	Obstruction Type			Storm Grate/Utility Type	
		N/A			N/A
		Yes		Surface Condition? (G/P)	Good

**Remove & Replace Curb Ramp With Two New Directional Ramps or Equivalent.**
