Access Compliance Report

Public Rights-of-Way

(Curb Ramps)

Intersection ID: 10032503	Main Street: N_CALDWELL_ST	Cross Street: N/A	Location: W
ADA ID: 2D1A6F10B0A2	Ramp Type: PerpDiag	Initial Pass/Fail: Fail	Overall Compliance: No
Severity Score: 33.75			
Codes/Mitigation Info/Possible Solution		Field Measurements/Component Compliance

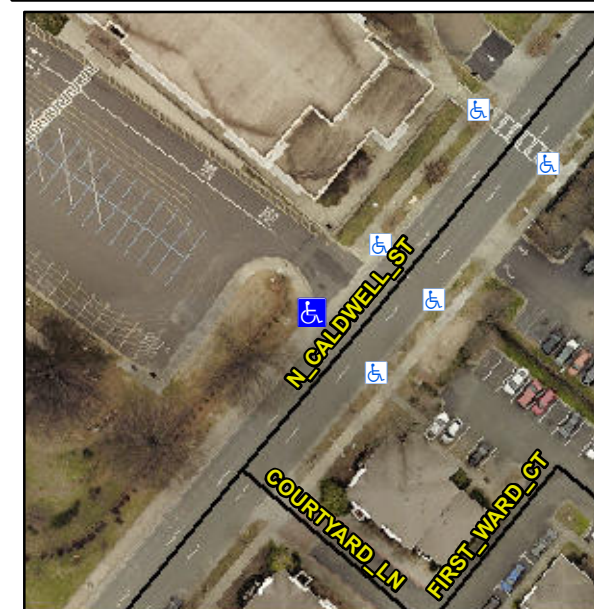
Not Found, R304.5.1, R304.2.2

Compliance	Description	Data	Compliance	Description	Data
N/A	Ramp Length (in)	48.5	No	Ramp Slope (%)	17.6
No	Ramp Width (in)	45.0	Yes	Ramp XSlope (%)	2.0
N/A	Flare Type LT	N/A	N/A	Flare Type RT	N/A
N/A	Flare Slope LT (%)	N/A	N/A	Flare Slope RT (%)	N/A
N/A	Flare Traversable LT?	N/A	N/A	Flare Traversable RT?	N/A
N/A	Landing Length (in)	N/A	N/A	DWS Provided?	N/A
N/A	Landing Width (in)	N/A	N/A	DWS Contrast?	N/A
N/A	Landing Slope (%)	N/A	N/A	DWS Length (in)	N/A
N/A	Landing X Slope (%)	N/A	N/A	DWS Full Width?	N/A
N/A	Landing Curb? (Y/N)	N/A	N/A	DWS Offset (in)	N/A
N/A	Shared Landing?	N/A			
N/A	Gutter Ponding?	N/A	N/A	Gutter Slope (%)	N/A
N/A	Gutter Lip Ht (in)	N/A	N/A	Gutter X Slope (%)	N/A
N/A	Painted X Walk1?	No	N/A	Painted X Walk2?	No
	X Walk 1 Direction	To SE		X Walk 2 Direction	To NE
N/A	X Walk 1 Width (in)	N/A	N/A	X Walk 2 Width (in)	N/A
	X Walk 1 Slope (%)	1.3		X Walk 2 Slope (%)	0.6
	X Walk 1 X Slope (%)	2.7		X Walk 2 X Slope (%)	4.6

N/A	Ramp inside XWalk1?	N/A	N/A	Ramp inside XWalk2?	N/A
	Road Slope (%)	4.5	N/A	Clear Space?	N/A
	Road X Slope (%)	0.9	N/A	Clear Space to XWalk (in)	N/A
N/A	Any Obstructions?	N/A	N/A	Storm Grate/Utility Hazard?	N/A
	Obstruction Type			Storm Grate/Utility Type	
		N/A			N/A
			Yes	Surface Condition? (G/P)	Good

Possible Solutions:

Remove & Replace Curb Ramp With Two New Directional Ramps or Equivalent.
