Access Compliance Report

Public Rights-of-Way

(Curb Ramps)

Intersection ID: 7294	Main Street: GLASGOW_RD	Cross Street: MOORES_CHAPEL_RD	Location: SW
ADA ID: 2D274EF42989	Ramp Type: Perp	Initial Pass/Fail: Fail	Overall Compliance: No
		Severity Score: 10

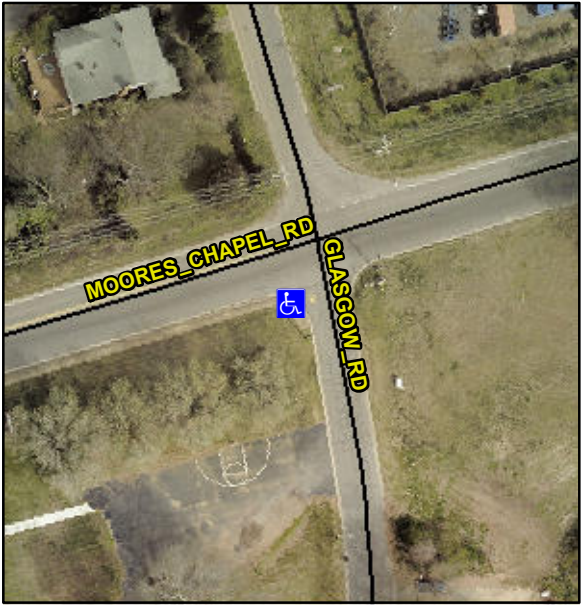
Possible Solutions:		Compliance	Description	Data
	Remove & Replace Entire Ramp.		N/A	Ramp Length (in)	60.0
			No	Ramp Width (in)	37.0
			N/A	Flare Type LT	N/A
			N/A	Flare Slope LT (%)	N/A
			N/A	Flare Traversable LT?	N/A
			N/A	Landing Length (in)	N/A
			N/A	Landing Width (in)	N/A
			N/A	Landing Slope (%)	N/A
			N/A	Landing X Slope (%)	N/A
<p>Surveyor Notes:</p> <p>N/A</p> <p>PROW/ADA:</p> <p>Not Found, R304.5.1, R304.5.3</p>			N/A	Flare Type RT	N/A
			N/A	Flare Slope RT (%)	N/A
			N/A	Flare Traversable RT?	N/A
			N/A	DWS Provided?	N/A
			N/A	DWS Contrast?	N/A
			N/A	DWS Length (in)	N/A
			N/A	DWS Full Width?	N/A
			N/A	DWS Offset (in)	N/A
			N/A	Gutter Ponding?	N/A
			N/A	Gutter Lip Ht (in)	0.5
			N/A	Painted X Walk1?	No
				X Walk 1 Direction	To E
			N/A	X Walk 1 Width (in)	N/A
				X Walk 1 Slope (%)	4.4
				X Walk 1 X Slope (%)	1.1

N/A	Ramp inside XWalk1?	N/A
				Road Slope (%)	1.1
				Road X Slope (%)	4.4
			N/A	Any Obstructions?	N/A
				Obstruction Type	
Total Cost: \$ 1850.00			N/A	Clear Space?	N/A
				Clear Space to XWalk (in)	N/A
			N/A	Storm Grate/Utility Hazard?	N/A
				Storm Grate/Utility Type	
			N/A	Surface Condition? (G/P)	N/A
			Yes		Good
