Access Compliance Report

Public Rights-of-Way

(Curb Ramps)

Intersection ID: N/A	Main Street: S_CLARKSON_ST	Cross Street: POST_ST	Location: E
ADA ID: 2D2D2C76D504	Ramp Type: Perp	Initial Pass/Fail: Fail	Overall Compliance: No
Severity Score: 8.75			
Codes/Mitigation Info/Possible Solution		Field Measurements/Component Compliance

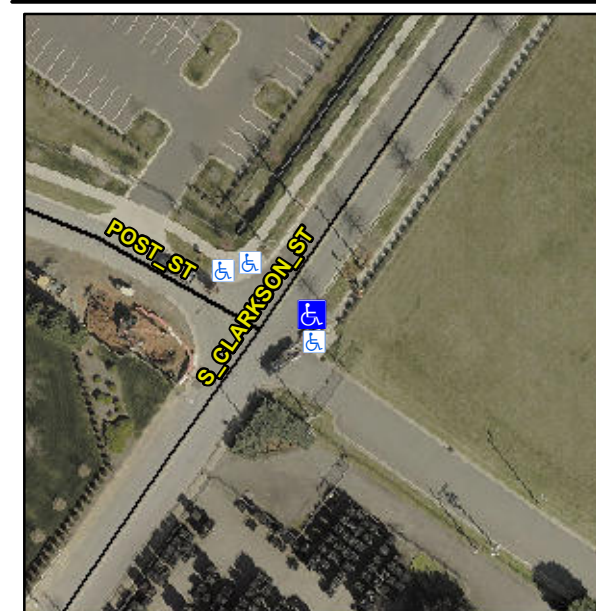
Compliance	Description	Data	Compliance	Description	Data
N/A	Ramp Length (in)	96.0	Yes	Ramp Slope (%)	7.4
No	Ramp Width (in)	47.0	Yes	Ramp XSlope (%)	1.4
N/A	Flare Type LT	N/A	N/A	Flare Type RT	N/A
N/A	Flare Slope LT (%)	N/A	N/A	Flare Slope RT (%)	N/A
N/A	Flare Traversable LT?	N/A	N/A	Flare Traversable RT?	N/A
N/A	Landing Length (in)	N/A	N/A	DWS Provided?	N/A
N/A	Landing Width (in)	N/A	N/A	DWS Contrast?	N/A
N/A	Landing Slope (%)	N/A	N/A	DWS Length (in)	N/A
N/A	Landing X Slope (%)	N/A	N/A	DWS Full Width?	N/A
N/A	Landing Curb? (Y/N)	N/A	N/A	DWS Offset (in)	N/A
N/A	Shared Landing?	N/A			
N/A	Gutter Ponding?	N/A	N/A	Gutter Slope (%)	N/A
N/A	Gutter Lip Ht (in)	N/A	N/A	Gutter X Slope (%)	N/A
N/A	Painted X Walk1?	No	N/A	Painted X Walk2?	N/A
	X Walk 1 Direction	To NW		X Walk 2 Direction	N/A
N/A	X Walk 1 Width (in)	N/A	N/A	X Walk 2 Width (in)	N/A
	X Walk 1 Slope (%)	2.9		X Walk 2 Slope (%)	N/A
	X Walk 1 X Slope (%)	3.7		X Walk 2 X Slope (%)	N/A

N/A	Ramp inside XWalk1?	N/A	N/A	Ramp inside XWalk2?	N/A
	Road Slope (%)	N/A	N/A	Clear Space?	N/A
	Road X Slope (%)	N/A	N/A	Clear Space to XWalk (in)	N/A
N/A	Any Obstructions?	N/A	N/A	Storm Grate/Utility Hazard?	N/A
	Obstruction Type			Storm Grate/Utility Type	
		N/A			N/A
			Yes	Surface Condition? (G/P)	Good

Possible Solutions:

Remove & Replace Entire Ramp.

Not Found, R304.5.1
