Access Compliance Report

Public Rights-of-Way

(Curb Ramps)

Intersection ID: 10025976	Main Street: ELM_LN	Cross Street: N/A	Location: NE
ADA ID: 2D33CC14C8C4	Ramp Type: PerpDiag	Initial Pass/Fail: Fail	Overall Compliance: No
Severity Score: 12.5			
Codes/Mitigation Info/Possible Solution		Field Measurements/Component Compliance

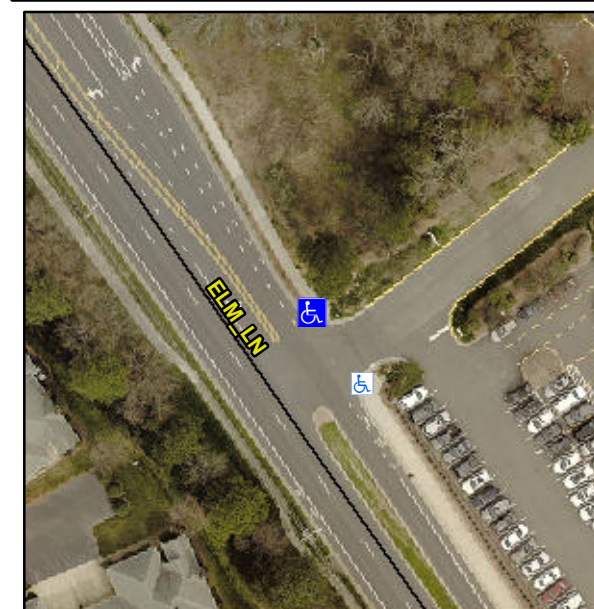
Not Found, R304.2.2

Compliance	Description	Data	Compliance	Description	Data
N/A	Ramp Length (in)	47.0	No	Ramp Slope (%)	11.3
Yes	Ramp Width (in)	48.0	Yes	Ramp XSlope (%)	0.3
N/A	Flare Type LT	N/A	N/A	Flare Type RT	N/A
N/A	Flare Slope LT (%)	N/A	N/A	Flare Slope RT (%)	N/A
N/A	Flare Traversable LT?	N/A	N/A	Flare Traversable RT?	N/A
N/A	Landing Length (in)	N/A	N/A	DWS Provided?	N/A
N/A	Landing Width (in)	N/A	N/A	DWS Contrast?	N/A
N/A	Landing Slope (%)	N/A	N/A	DWS Length (in)	N/A
N/A	Landing X Slope (%)	N/A	N/A	DWS Full Width?	N/A
N/A	Landing Curb? (Y/N)	N/A	N/A	DWS Offset (in)	N/A
N/A	Shared Landing?	N/A			
N/A	Gutter Ponding?	N/A	N/A	Gutter Slope (%)	N/A
N/A	Gutter Lip Ht (in)	N/A	N/A	Gutter X Slope (%)	N/A
N/A	Painted X Walk1?	No	N/A	Painted X Walk2?	No
	X Walk 1 Direction	To SW		X Walk 2 Direction	To SE
N/A	X Walk 1 Width (in)	N/A	N/A	X Walk 2 Width (in)	N/A
	X Walk 1 Slope (%)	1.0		X Walk 2 Slope (%)	1.4
	X Walk 1 X Slope (%)	1.3		X Walk 2 X Slope (%)	1.9

Remove & Replace Curb Ramp With Two New Directional Ramps or Equivalent.

Total Cost: \$ 3200.00
