Access Compliance Report

Public Rights-of-Way

(Curb Ramps)

Intersection ID: 21797	Main Street: GALLERIA_BV	Cross Street: MONROE_RD	Location: NE
ADA ID: 2D3B6913FF91	Ramp Type: Perp	Initial Pass/Fail: Fail	Overall Compliance: No
Codes/Mitigation Info/Possible Solution		Field Measurements/Component Compliance	
Severity Score: 18.75

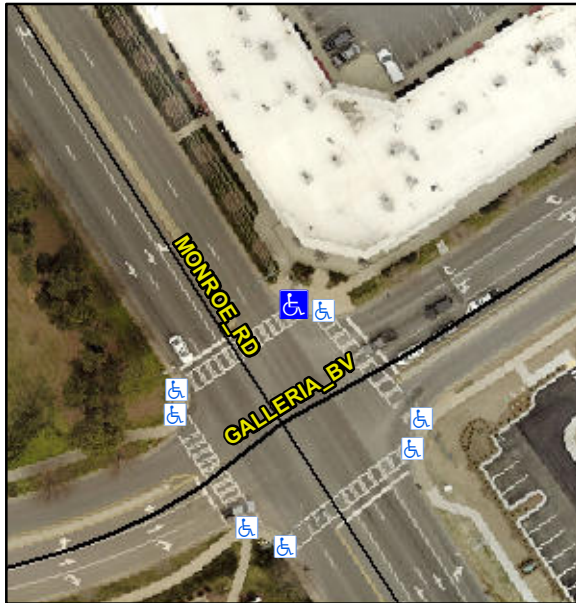
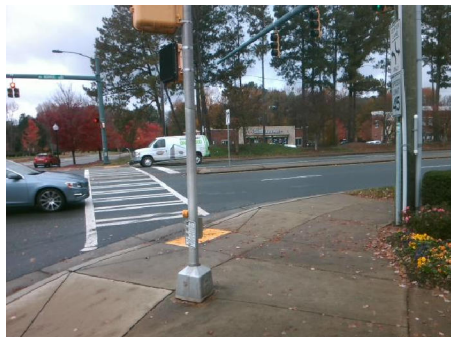
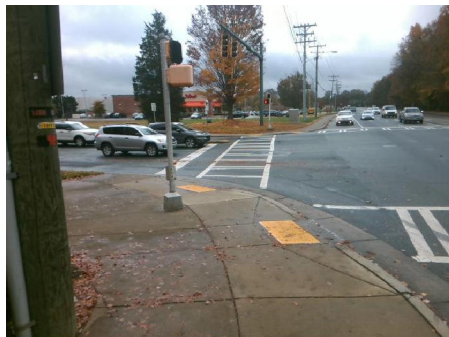
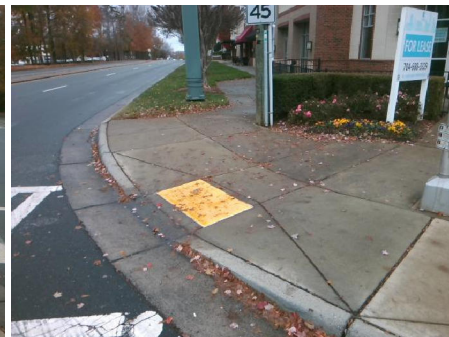
R304.5.1, R304.5.3

Compliance	Description	Data	Compliance	Description	Data
N/A	Ramp Length (in)	154.0	Yes	Ramp Slope (%)	5.6
No	Ramp Width (in)	35.0	No	Ramp XSlope (%)	3.5
N/A	Flare Type LT	N/A	N/A	Flare Type RT	N/A
N/A	Flare Slope LT (%)	N/A	N/A	Flare Slope RT (%)	N/A
N/A	Flare Traversable LT?	N/A	N/A	Flare Traversable RT?	N/A
N/A	Landing Length (in)	N/A	N/A	DWS Provided?	N/A
N/A	Landing Width (in)	N/A	N/A	DWS Contrast?	N/A
N/A	Landing Slope (%)	N/A	N/A	DWS Length (in)	N/A
N/A	Landing X Slope (%)	N/A	N/A	DWS Full Width?	N/A
N/A	Landing Curb? (Y/N)	N/A	N/A	DWS Offset (in)	N/A
N/A	Shared Landing?	N/A			
N/A	Gutter Ponding?	N/A	N/A	Gutter Slope (%)	N/A
N/A	Gutter Lip Ht (in)	N/A	N/A	Gutter X Slope (%)	N/A
N/A	Painted X Walk1?	Yes	N/A	Painted X Walk2?	N/A
	X Walk 1 Direction	To SW		X Walk 2 Direction	N/A
N/A	X Walk 1 Width (in)	96.0	N/A	X Walk 2 Width (in)	N/A
	X Walk 1 Slope (%)	2.6		X Walk 2 Slope (%)	N/A
	X Walk 1 X Slope (%)	1.0		X Walk 2 X Slope (%)	N/A

N/A	Ramp inside XWalk1?	Yes	N/A	Ramp inside XWalk2?	N/A
	Road Slope (%)	N/A	N/A	Clear Space?	N/A
	Road X Slope (%)	N/A	N/A	Clear Space to XWalk (in)	N/A
N/A	Any Obstructions?	N/A	N/A	Storm Grate/Utility Hazard?	N/A
	Obstruction Type			Storm Grate/Utility Type	
		N/A			N/A
		Yes		Surface Condition? (G/P)	Good

Remove & Replace Entire Ramp.
