# Access Compliance Report

## Public Rights-of-Way

### (Curb Ramps)

Intersection ID: 10024247	Main Street: CPCC_HARRIS_CAMPUS_DR	Cross Street: N/A	Location: SE
ADA ID: 2D5453BC8A69	Ramp Type: ParaDiag	Initial Pass/Fail: Fail	Overall Compliance: No
			Severity Score: 13.75

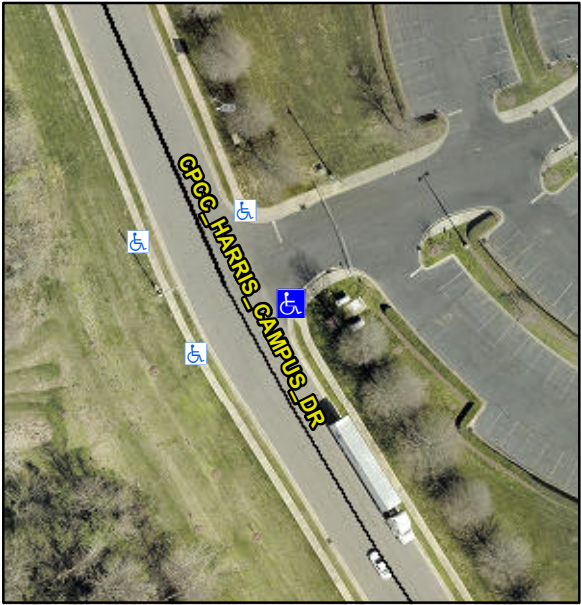
Possible Solutions:		<b>Compliance</b>	<b>Description</b>	<b>Data</b>
	<b>Remove &amp; Replace Curb Ramp With Two New Directional Ramps or Equivalent.</b>		<b>N/A</b>	Ramp Length LT (in)	<b>48.0</b>
			<b>Yes</b>	Ramp Width LT (in)	<b>58.0</b>
			<b>No</b>	Ramp Slope LT (%)	<b>10.3</b>
			<b>Yes</b>	Ramp XSlope LT (%)	<b>1.1</b>
			<b>N/A</b>	Landing Length (in)	<b>N/A</b>
			<b>N/A</b>	Landing Width (in)	<b>N/A</b>
			<b>N/A</b>	Landing Slope (%)	<b>N/A</b>
			<b>N/A</b>	Landing X Slope (%)	<b>N/A</b>
			<b>N/A</b>	Landing Curb? (Y/N)	<b>N/A</b>
<p>Surveyor Notes:</p> <p><b>N/A</b></p> <p>PROW/ADA:</p> <p><b>R304.3.2, R304.5.3</b></p>			<b>N/A</b>	Ramp XSlope RT (%)	<b>4.1</b>
			<b>N/A</b>	DWS Provided?	<b>N/A</b>
			<b>N/A</b>	DWS Contrast?	<b>N/A</b>
			<b>N/A</b>	DWS Length (in)	<b>N/A</b>
			<b>N/A</b>	DWS Full Width?	<b>N/A</b>

<b>N/A</b>	DWS Offset (in)	<b>N/A</b>
			<b>N/A</b>	Gutter Slope (%)	<b>N/A</b>
			<b>N/A</b>	Gutter X Slope (%)	<b>N/A</b>
			<b>N/A</b>	Painted X Walk1?	<b>No</b>
			<b>N/A</b>	Painted X Walk2?	<b>No</b>
			<b>N/A</b>	X Walk 1 Direction	<b>To NW</b>
			<b>N/A</b>	X Walk 2 Direction	<b>To SW</b>
			<b>N/A</b>	X Walk 1 Width (in)	<b>N/A</b>
			<b>N/A</b>	X Walk 2 Width (in)	<b>N/A</b>
			<b>3.5</b>	X Walk 1 Slope (%)	<b>1.8</b>
			<b>1.5</b>	X Walk 2 Slope (%)	<b>5.0</b>
			<b>N/A</b>	X Walk 1 X Slope (%)	<b>N/A</b>
			<b>N/A</b>	X Walk 2 X Slope (%)	<b>N/A</b>
			<b>N/A</b>	Ramp inside XWalk1?	<b>N/A</b>
			<b>N/A</b>	Ramp inside XWalk2?	<b>N/A</b>
			<b>3.4</b>	Road Slope (%)	<b>N/A</b>
			<b>3.4</b>	Clear Space?	<b>N/A</b>
			<b>N/A</b>	Clear Space to XWalk (in)	<b>N/A</b>
			<b>N/A</b>	Storm Grate/Utility Hazard?	<b>N/A</b>
			<b>N/A</b>	Storm Grate/Utility Type	<b>N/A</b>
			<b>N/A</b>	Any Obstructions?	<b>N/A</b>

<b>N/A</b>	Obstruction Type	<b>N/A</b>
			<b>N/A</b>	Surface Condition? (G/P)	<b>Good</b>
			<b>N/A</b>	Curb Slope (%)	<b>8.6</b>

Total Cost: \$ 3200.00
