# Access Compliance Report

## Public Rights-of-Way

### (Curb Ramps)

Intersection ID: 16290	Main Street: ELDER_AV	Cross Street: RICHLAND_DR	Location:	S
ADA ID: 2D5772B9800B	Ramp Type: Combination1	Initial Pass/Fail: Fail	Overall Compliance: No	Severity Score: 30

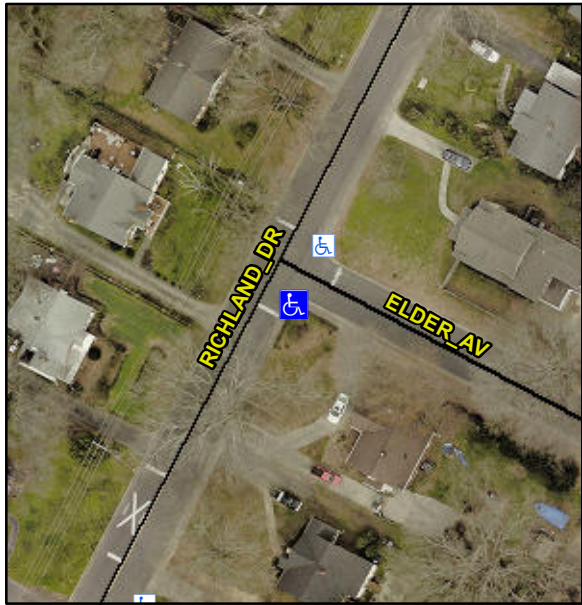
Possible Solutions:		<b>Compliance</b>	<b>Description</b>	<b>Data</b>	<b>Compliance</b>	<b>Description</b>	<b>Data</b>
	<b>Remove &amp; Replace Entire Ramp.</b>		N/A	Ramp Length LT (in)	45.0	N/A	Ramp Length RT (in)	33.0
			Yes	Ramp Width LT (in)	48.0	Yes	Ramp Width RT (in)	48.0
			Yes	Ramp Slope LT (%)	0.4	Yes	Ramp Slope RT (%)	7.7
			Yes	Ramp XSlope LT (%)	0.9	Yes	Ramp XSlope RT (%)	1.7
			N/A	Ramp Length (in)	52.0	Yes	Ramp Slope (%)	2.8
			No	Ramp Width (in)	34.0	No	Ramp XSlope (%)	6.3
	Surveyor Notes:		N/A	Flare Type LT	N/A	N/A	Flare Type RT	N/A
	<b>LT RP &lt; 5%</b>		N/A	Flare Slope LT (%)	N/A	N/A	Flare Slope RT (%)	N/A
			N/A	Flare Traversable LT?	N/A	N/A	Flare Traversable RT?	N/A
PROW/ADA:		N/A	Landing Length (in)	N/A	N/A	DWS Provided?	N/A	
<b>Not Found, R304.5.1, R304.5.3</b>		N/A	Landing Width (in)	N/A	N/A	DWS Contrast?	N/A

N/A	Landing Slope (%)	N/A	N/A	DWS Length (in)	N/A	
		N/A	Landing X Slope (%)	N/A	N/A	DWS Full Width?	N/A	
		N/A	Landing Curb? (Y/N)	N/A	N/A	DWS Offset (in)	N/A	
		N/A	Shared Landing?	N/A				
		N/A	Gutter Ponding?	N/A	N/A	Gutter Slope (%)	N/A	
		N/A	Gutter Lip Ht (in)	N/A	N/A	Gutter X Slope (%)	N/A	
		N/A	Painted X Walk1?	No	N/A	Painted X Walk2?	N/A	
			X Walk 1 Direction	To NE		X Walk 2 Direction	N/A	
			X Walk 1 Width (in)	N/A		X Walk 2 Width (in)	N/A	
			X Walk 1 Slope (%)	1.7		X Walk 2 Slope (%)	N/A	
			X Walk 1 X Slope (%)	2.0		X Walk 2 X Slope (%)	N/A	
		N/A	Ramp inside XWalk1?	N/A	N/A	Ramp inside XWalk2?	N/A	
			Road Slope (%)	N/A		Clear Space?	N/A	
			Road X Slope (%)	N/A	N/A	Clear Space to XWalk (in)	N/A	
					N/A	Any Obstruction?	N/A	
						Obstruction Type	N/A	
								N/A
					N/A	Storm Grate/Utility Hazard?	N/A	
						Storm Grate/Utility Type	N/A	
								N/A
			Yes	Surface Condition? (G/P)	Good

Curb Slope (%)	6.5			
Street 1 Name		StopSign						
Stop Condition-Street 1		ELDER AV						
Street 2 Name		N/A						
Stop Condition-Street 2		N/A						
Total Cost:		\$ 1800.00
