Access Compliance Report

Public Rights-of-Way

(Curb Ramps)

Intersection ID: 43242	Main Street: I-485_RA	Cross Street: S_I-77_HY	Location:	N
ADA ID: 2D5E16B206F0	Ramp Type: Perp	Initial Pass/Fail: Fail	Overall Compliance: No	Severity Score: 10
Codes/Mitigation Info/Possible Solution		Field Measurements/Component Compliance

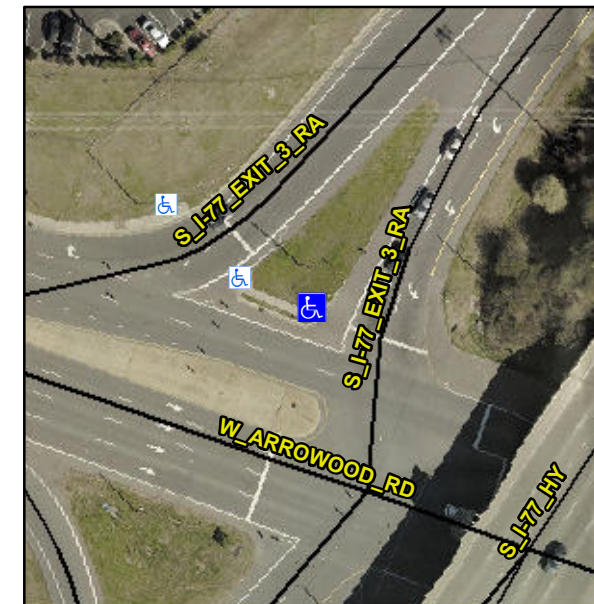
Not Found, R304.5.1, R304.5.3

Compliance	Description	Data	Compliance	Description	Data
N/A	Ramp Length (in)	48.0	Yes	Ramp Slope (%)	5.7
No	Ramp Width (in)	36.0	No	Ramp XSlope (%)	2.3
N/A	Flare Type LT	N/A	N/A	Flare Type RT	N/A
N/A	Flare Slope LT (%)	N/A	N/A	Flare Slope RT (%)	N/A
N/A	Flare Traversable LT?	N/A	N/A	Flare Traversable RT?	N/A
N/A	Landing Length (in)	N/A	N/A	DWS Provided?	N/A
N/A	Landing Width (in)	N/A	N/A	DWS Contrast?	N/A
N/A	Landing Slope (%)	N/A	N/A	DWS Length (in)	N/A
N/A	Landing X Slope (%)	N/A	N/A	DWS Full Width?	N/A
N/A	Landing Curb? (Y/N)	N/A	N/A	DWS Offset (in)	N/A
N/A	Shared Landing?	N/A			
N/A	Gutter Ponding?	N/A	N/A	Gutter Slope (%)	N/A
N/A	Gutter Lip Ht (in)	N/A	N/A	Gutter X Slope (%)	N/A
N/A	Painted X Walk1?	No	N/A	Painted X Walk2?	N/A
	X Walk 1 Direction	To SE		X Walk 2 Direction	N/A
N/A	X Walk 1 Width (in)	N/A	N/A	X Walk 2 Width (in)	N/A
	X Walk 1 Slope (%)	1.8		X Walk 2 Slope (%)	N/A
	X Walk 1 X Slope (%)	1.3		X Walk 2 X Slope (%)	N/A

Remove & Replace Entire Ramp.
