Access Compliance Report

Public Rights-of-Way

(Curb Ramps)

Intersection ID: 18845	Main Street: HORTON_CT	Cross Street: SENECA_PL	Location: SE
ADA ID: 2D60B38E4C9A	Ramp Type: BlendTrans1	Initial Pass/Fail: Fail	Overall Compliance: No
Severity Score: 10			
Codes/Mitigation Info/Possible Solution		Field Measurements/Component Compliance

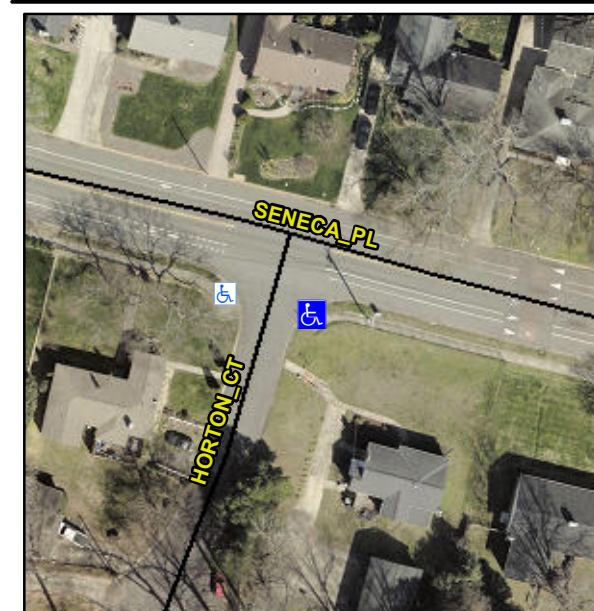
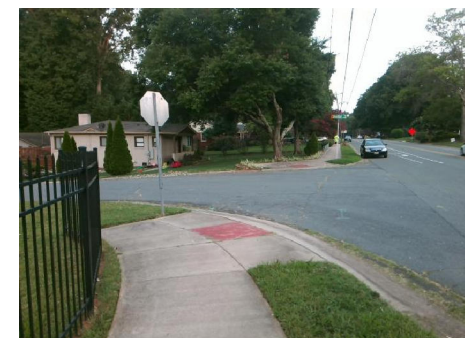
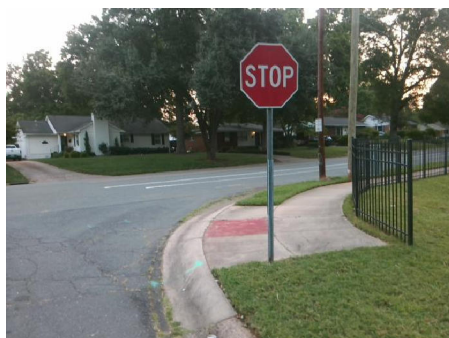
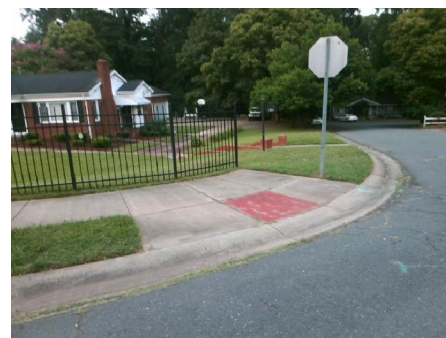
Not Found, R304.5.1, R304.5.3

Compliance	Description	Data	Compliance	Description	Data
N/A	Ramp Length (in)	48.0	Yes	BlendTrans Slope (%)	4.4
No	Ramp Width (in)	43.5	No	BlendTrans XSlope (%)	5.0
N/A	Flare Type LT	N/A	N/A	Flare Type RT	N/A
N/A	Flare Slope LT (%)	N/A	N/A	Flare Slope RT (%)	N/A
N/A	Flare Traversable LT?	N/A	N/A	Flare Traversable RT?	N/A
N/A	Landing Length (in)	N/A	N/A	DWS Provided?	N/A
N/A	Landing Width (in)	N/A	N/A	DWS Contrast?	N/A
N/A	Landing Slope (%)	N/A	N/A	DWS Length (in)	N/A
N/A	Landing X Slope (%)	N/A	N/A	DWS Full Width?	N/A
N/A	Landing Curb? (Y/N)	N/A	N/A	DWS Offset (in)	N/A
N/A	Shared Landing?	N/A			
N/A	Gutter Ponding?	N/A	N/A	Gutter Slope (%)	N/A
N/A	Gutter Lip Ht (in)	N/A	N/A	Gutter X Slope (%)	N/A
N/A	Painted X Walk1?	No	N/A	Painted X Walk2?	No
	X Walk 1 Direction	To N		X Walk 2 Direction	To NW
	X Walk 1 Width (in)	N/A		X Walk 2 Width (in)	N/A
	X Walk 1 Slope (%)	6.0		X Walk 2 Slope (%)	5.9
	X Walk 1 X Slope (%)	3.8		X Walk 2 X Slope (%)	4.9

N/A	Ramp inside XWalk1?	N/A	N/A	Ramp inside XWalk2?	N/A
	Road Slope (%)	2.2		Clear Space?	N/A
	Road X Slope (%)	7.6	N/A	Clear Space to XWalk (in)	N/A
N/A	Any Obstructions?	N/A	N/A	Storm Grate/Utility Hazard?	N/A
	Obstruction Type			Storm Grate/Utility Type	
		N/A			N/A
			Yes	Surface Condition? (G/P)	Good
			No	Curb Slope (%)	18.3

Remove & Replace Curb Ramp With Two New Directional Ramps or Equivalent.
