## **Access Compliance Report Public Rights-of-Way** (Curb Ramps)

Intersection ID: 20808 Main Street: EDGEWATER DR **Cross Street: MONTPELIER RD** Location: NW **Overall Compliance: No Severity Score:** 12.5 ADA ID: 2D66570597C6 Ramp Type: PerpDiag Initial Pass/Fail: Fail

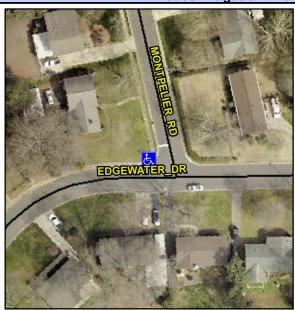
Compliance Description Data Yes N/A Ramp Length (in) 60.0 Ramp Slope (%) 6.1 No Ramp XSlope (%) Yes Ramp Width (in) 48.0 5.5 N/A N/A Flare Type LT N/A Flare Type RT N/A N/A N/A N/A Flare Slope RT (%) N/A Flare Slope LT (%) N/A Flare Traversable LT? N/A N/A Flare Traversable RT? N/A N/A N/A N/A **DWS Provided?** N/A Landing Length (in) N/A Landing Width (in) N/A N/A **DWS Contrast?** N/A N/A N/A N/A Landing Slope (%) DWS Length (in) N/A N/A Landing X Slope (%) N/A N/A DWS Full Width? N/A N/A Landing Curb? (Y/N) N/A N/A DWS Offset (in) N/A N/A N/A Shared Landing? N/A **Gutter Ponding?** N/A N/A Gutter Slope (%) N/A N/A Gutter Lip Ht (in) N/A N/A Gutter X Slope (%) N/A N/A Painted X Walk1? No N/A Painted X Walk2? No X Walk 1 Direction To S X Walk 2 Direction To E N/A N/A X Walk 2 Width (in) X Walk 1 Width (in) N/A X Walk 1 Slope (%) 0.2 X Walk 2 Slope (%) 3.5 X Walk 1 X Slope (%) 4.4 X Walk 2 X Slope (%) 0.7 N/A N/A N/A Ramp inside XWalk2? N/A Ramp inside XWalk1? Road Slope (%) 4.9 N/A Clear Space? N/A N/A Road X Slope (%) 2.2 Clear Space to XWalk (in) N/A N/A N/A N/A Any Obstructions? Storm Grate/Utility Hazard? N/A **Obstruction Type** Storm Grate/Utility Type N/A N/A

**EDGEWATER DR** None **MONTPELIER RD** StopSign Possible Solutions: Compliance Description Remove & Replace Curb Ramp With Two New Directional Ramps or Equivalent. Surveyor Notes: N/A PROW/ADA: Not Found, R304.5.3
