Access Compliance Report

Public Rights-of-Way

(Curb Ramps)

Intersection ID: N/A	Main Street: POTOMAC_RIVER_PY	Cross Street: NATIONAL_AV	Location: N
ADA ID: 2D6750A20EB8	Ramp Type: Directional1	Initial Pass/Fail: Fail	Overall Compliance: No
Severity Score: 12.5			
Codes/Mitigation Info/Possible Solution		Field Measurements/Component Compliance

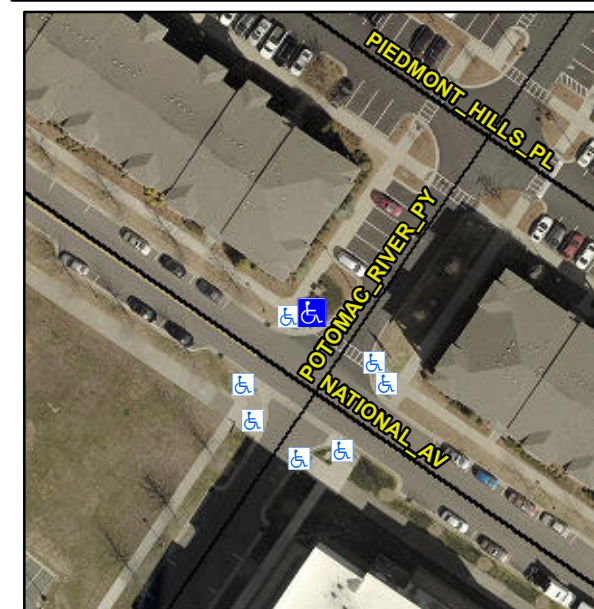
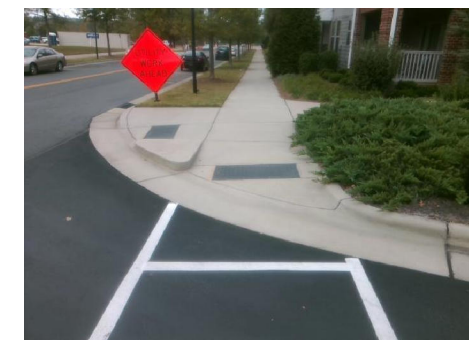
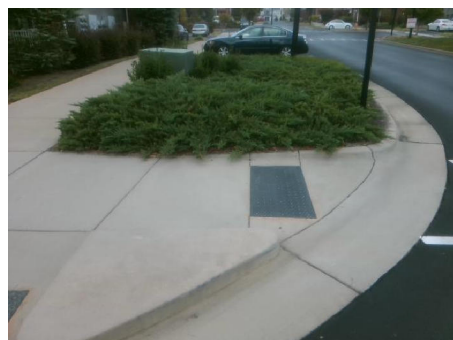
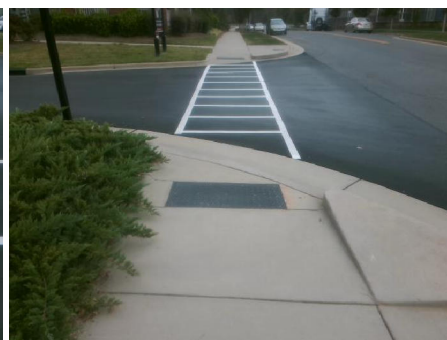
Compliance	Description	Data	Compliance	Description	Data
N/A	Ramp Length (in)	63.5	N/A	Grade Break?	N/A
Yes	Ramp Width (in)	70.0	N/A	Grade Break Slope (%)	0.0
Yes	Ramp Slope (%)	0.7	N/A	Grade Break XSlope (%)	0.0
No	Ramp XSlope (%)	5.5			
N/A	Flare Type LT	N/A	N/A	Flare Type RT	N/A
N/A	Flare Slope LT (%)	N/A	N/A	Flare Slope RT (%)	0.0
N/A	Flare Traversable LT?	N/A	N/A	Flare Traversable RT?	N/A
N/A	Landing Length (in)	0.0	N/A	DWS Provided?	N/A
N/A	Landing Width (in)	0.0	N/A	DWS Contrast?	N/A
N/A	Landing Slope (%)	0.0	N/A	DWS Length (in)	N/A
N/A	Landing X Slope (%)	0.0	N/A	DWS Full Width?	N/A
N/A	Landing Curb? (Y/N)	N/A	N/A	DWS Offset LT (in)	N/A
N/A	Shared Landing?	N/A	N/A	DWS Offset RT (in)	N/A
N/A	Gutter Ponding?	0.0	N/A	Gutter Slope (%)	N/A
N/A	Gutter Lip Ht (in)	0.0	N/A	Gutter X Slope (%)	N/A
N/A	Painted X Walk1?	Yes		Road Slope (%)	4.1
	X Walk 1 Direction	To E		Road X Slope (%)	3.1
	X Walk 1 Width (in)	64.0		Clear Space?	N/A

X Walk 1 Slope (%)	4.1	N/A	Clear Space to XWalk (in)	N/A
	X Walk 1 X Slope (%)	3.1	N/A	Storm Grate/Utility Hazard?	N/A
N/A	Ramp inside XWalk1?	Yes		Storm Grate/Utility Type	
N/A	Any Obstructions?	N/A			N/A
	Obstruction Type		Yes	Surface Condition? (G/P)	Good
			N/A	Curb Slope (%)	6.4

Remove & Replace Entire Ramp.

R304.5.3
