## **Access Compliance Report Public Rights-of-Way** (Curb Ramps)

Intersection ID: 14456 Main Street: CLEVELAND\_AV Cross Street: SOUTH\_BV Location: SE

Overall Compliance: No Severity Score: 28.75 ADA ID: 2D743F5543B4 Ramp Type: Perp Initial Pass/Fail: Fail

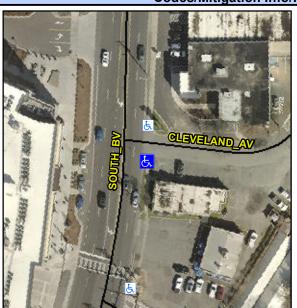
Field Measurements/Component Compliance						
Comp	liance Description	Data	Comp	liance Description	Data	
N/A	Ramp Length (in)	60.0	No	Ramp Slope (%)	11.4	
Yes	Ramp Width (in)	48.0	No	Ramp XSlope (%)	3.1	
N/A	Flare Type LT	N/A	N/A	Flare Type RT	N/A	
N/A	Flare Slope LT (%)	N/A	N/A	Flare Slope RT (%)	N/A	
N/A	Flare Traversable LT?	N/A	N/A	Flare Traversable RT?	N/A	
N/A	Landing Length (in)	N/A	N/A	DWS Provided?	N/A	
N/A	Landing Width (in)	N/A	N/A	DWS Contrast?	N/A	
N/A	Landing Slope (%)	N/A	N/A	DWS Length (in)	N/A	
N/A	Landing X Slope (%)	N/A	N/A	DWS Full Width?	N/A	
N/A	Landing Curb? (Y/N)	N/A	N/A	DWS Offset (in)	N/A	
N/A	Shared Landing?	N/A				
N/A	Gutter Ponding?	N/A	N/A	Gutter Slope (%)	N/A	
N/A	Gutter Lip Ht (in)	N/A	N/A	Gutter X Slope (%)	N/A	
N/A	Painted X Walk1?	No	N/A	Painted X Walk2?	N/A	
	X Walk 1 Direction	To NE		X Walk 2 Direction	N/A	
N/A	X Walk 1 Width (in)	N/A	N/A	X Walk 2 Width (in)	N/A	
	X Walk 1 Slope (%)	2.8		X Walk 2 Slope (%)	N/A

X Walk 1 X Slope (%)	4.8		X Walk 2 X Slope (%)	N/A	
N/A	Ramp inside XWalk1?	N/A	N/A	Ramp inside XWalk2?	N/A	
	Road Slope (%)	N/A	N/A	Clear Space?	N/A	
	Road X Slope (%)	N/A	N/A	Clear Space to XWalk (in)	N/A	
N/A	Any Obstructions?	N/A	N/A	Storm Grate/Utility Hazard?	N/A	
	Obstruction Type			Storm Grate/Utility Type		
		N/A			N/A	
			No	Surface Condition? (G/P)	Poor	
7	The second second

Possible Solutions:	Co
Remove & Replace Entire Ramp.	N/A
	Ye
	N/A
	N/A
	N/A
	N/A
Surveyor Notes:	N/A
N/A	N/A
	N/A
	N/A
	N/A
PROW/ADA:	N/A
Not Found, R304.2.2, R304.5.3,	N/A
R302.7	N/A
	N/A
	N/A
