# Access Compliance Report

## Public Rights-of-Way

### (Curb Ramps)

Intersection ID: 48999	Main Street: STEELECROFT_FARM_LN	Cross Street: STEELECROFT_PY	Location: NW
ADA ID: 2D76D4C09085	Ramp Type: Perp	Initial Pass/Fail: Fail	Overall Compliance: No
Severity Score: 1.25			
Codes/Mitigation Info/Possible Solution		Field Measurements/Component Compliance

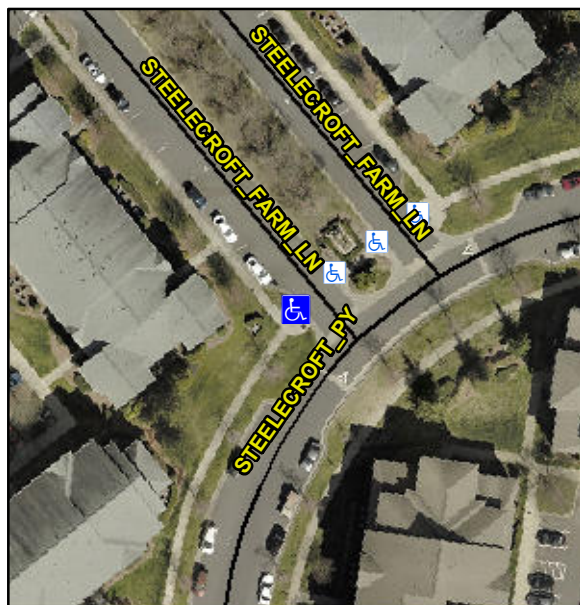
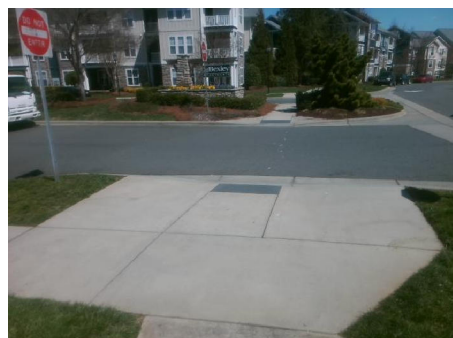
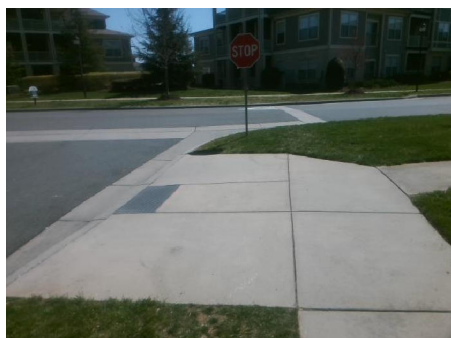
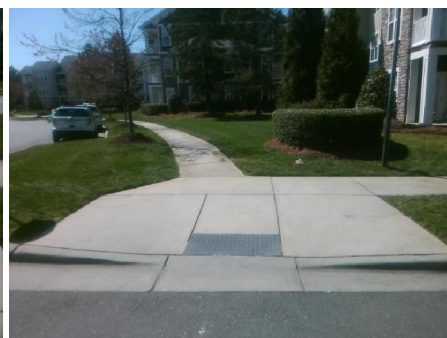
**Not Found, R304.5.3**

Compliance	Description	Data	Compliance	Description	Data
N/A	Ramp Length (in)	96.0	Yes	Ramp Slope (%)	6.2
Yes	Ramp Width (in)	50.0	No	Ramp XSlope (%)	2.6
N/A	Flare Type LT	N/A	N/A	Flare Type RT	N/A
N/A	Flare Slope LT (%)	N/A	N/A	Flare Slope RT (%)	N/A
N/A	Flare Traversable LT?	N/A	N/A	Flare Traversable RT?	N/A
N/A	Landing Length (in)	N/A	N/A	DWS Provided?	N/A
N/A	Landing Width (in)	N/A	N/A	DWS Contrast?	N/A
N/A	Landing Slope (%)	N/A	N/A	DWS Length (in)	N/A
N/A	Landing X Slope (%)	N/A	N/A	DWS Full Width?	N/A
N/A	Landing Curb? (Y/N)	N/A	N/A	DWS Offset (in)	N/A
N/A	Shared Landing?	N/A			
N/A	Gutter Ponding?	N/A	N/A	Gutter Slope (%)	N/A
N/A	Gutter Lip Ht (in)	N/A	N/A	Gutter X Slope (%)	N/A
N/A	Painted X Walk1?	No	N/A	Painted X Walk2?	N/A
	X Walk 1 Direction	To NE		X Walk 2 Direction	N/A
N/A	X Walk 1 Width (in)	N/A	N/A	X Walk 2 Width (in)	N/A
	X Walk 1 Slope (%)	0.6		X Walk 2 Slope (%)	N/A
	X Walk 1 X Slope (%)	1.4		X Walk 2 X Slope (%)	N/A

N/A	Ramp inside XWalk1?	N/A	N/A	Ramp inside XWalk2?	N/A
	Road Slope (%)	N/A	N/A	Clear Space?	N/A
	Road X Slope (%)	N/A	N/A	Clear Space to XWalk (in)	N/A
N/A	Any Obstructions?	N/A	N/A	Storm Grate/Utility Hazard?	N/A
	Obstruction Type			Storm Grate/Utility Type	
		N/A			N/A
			Yes	Surface Condition? (G/P)	Good

**Remove & Replace Entire Ramp.**

Total Cost: \$ 1850.00
