Access Compliance Report Public Rights-of-Way (Curb Ramps)

Intersection ID: 8503Main Street:TIMEPLANNER_DRCross Street: ATANDO_AVLocation:NWADA ID: 2D7F9EB53C2FRamp Type:PerpInitial Pass/Fail: FailOverall Compliance: NoSeverity Score:22.5

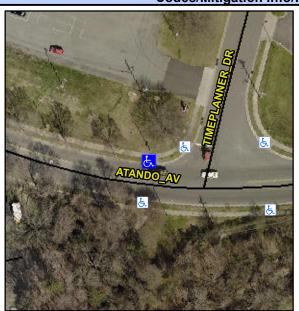
Field Measurements/Component Compliance								
Comp	liance Description	Data	Comp	liance	Description	Data		
N/A	Ramp Length (in)	60.0	No	Ramp	Slope (%)	9.8		
No	Ramp Width (in)	45.0	No	Ramp	XSlope (%)	2.2		
N/A	Flare Type LT	N/A	N/A	Flare	Type RT	N/A		
N/A	Flare Slope LT (%)	N/A	N/A	Flare	Slope RT (%)	N/A		
N/A	Flare Traversable LT?	N/A	N/A	Flare	Traversable RT?	N/A		
N/A	Landing Length (in)	N/A	N/A	DWS	Provided?	N/A		
N/A	Landing Width (in)	N/A	N/A	DWS	Contrast?	N/A		
N/A	Landing Slope (%)	N/A	N/A	DWS	Length (in)	N/A		
N/A	Landing X Slope (%)	N/A	N/A	DWS	Full Width?	N/A		
N/A	Landing Curb? (Y/N)	N/A	N/A	DWS	Offset (in)	N/A		
N/A	Shared Landing?	N/A						
N/A	Gutter Ponding?	N/A	N/A	Gutte	r Slope (%)	N/A		
N/A	Gutter Lip Ht (in)	N/A	N/A	Gutte	r X Slope (%)	N/A		
N/A	Painted X Walk1?	No	N/A	Paint	ed X Walk2?	N/A		
	X Walk 1 Direction	To S		X Wa	lk 2 Direction	N/A		
N/A	X Walk 1 Width (in)	N/A	N/A	X Wa	lk 2 Width (in)	N/A

X Walk 1 Slope (%)	1.7		X Wa	lk 2 Slope (%)	N/A		
	X Walk 1 X Slope (%)	1.5		X Wa	lk 2 X Slope (%)	N/A		
N/A	Ramp inside XWalk1?	N/A	N/A	Ram	inside XWalk2?	N/A		
	Road Slope (%)	N/A	N/A	Clear	Space?	N/A		
	Road X Slope (%)	N/A	N/A	Clear	Space to XWalk (in)	N/A		
N/A	Any Obstructions?	N/A	N/A	Storn	n Grate/Utility Hazard?	N/A		
	Obstruction Type			Storn	n Grate/Utility Type			
		N/A				N/A		
			Yes	Surfa	ce Condition? (G/P)	Good

i ossible solution	
Possible Solutions:	9
Remove & Replace Entire Ramp.	N
•	N
	N
	1
	1
	1
Surveyor Notes:	1
N/A	1
	1
	1
	1
PROW/ADA:	1
R304.5.1, R304.2.2, R304.5.3	N
	N
	N
	1
