Access Compliance Report

Public Rights-of-Way

(Curb Ramps)

Intersection ID: 54370	Main Street: LONGWALL_LN	Cross Street: CALLONWOOD_DR	Location: SW
ADA ID: 2D8935FBC50A	Ramp Type: Perp	Initial Pass/Fail: Fail	Overall Compliance: No
Severity Score: 13.75			
Codes/Mitigation Info/Possible Solution		Field Measurements/Component Compliance

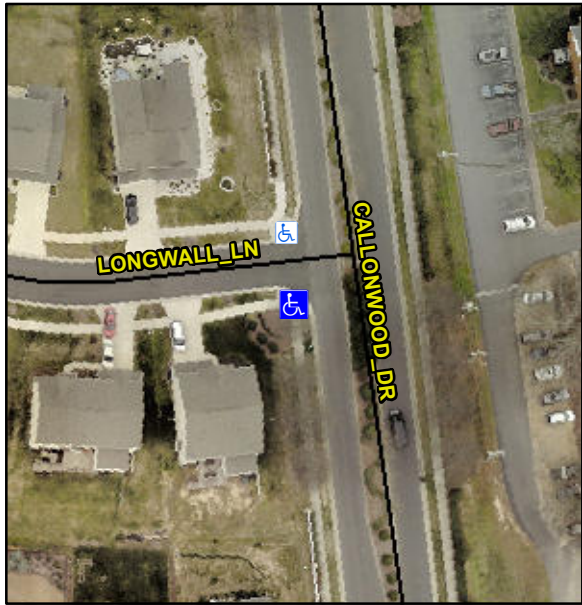
Not Found, R304.2.2, R304.5.3

Compliance	Description	Data	Compliance	Description	Data
N/A	Ramp Length (in)	58.0	No	Ramp Slope (%)	8.7
Yes	Ramp Width (in)	48.0	No	Ramp XSlope (%)	2.1
N/A	Flare Type LT	N/A	N/A	Flare Type RT	N/A
N/A	Flare Slope LT (%)	N/A	N/A	Flare Slope RT (%)	N/A
N/A	Flare Traversable LT?	N/A	N/A	Flare Traversable RT?	N/A
N/A	Landing Length (in)	N/A	N/A	DWS Provided?	N/A
N/A	Landing Width (in)	N/A	N/A	DWS Contrast?	N/A
N/A	Landing Slope (%)	N/A	N/A	DWS Length (in)	N/A
N/A	Landing X Slope (%)	N/A	N/A	DWS Full Width?	N/A
N/A	Landing Curb? (Y/N)	N/A	N/A	DWS Offset (in)	N/A
N/A	Shared Landing?	N/A			
N/A	Gutter Ponding?	N/A	N/A	Gutter Slope (%)	N/A
N/A	Gutter Lip Ht (in)	N/A	N/A	Gutter X Slope (%)	N/A
N/A	Painted X Walk1?	No	N/A	Painted X Walk2?	N/A
	X Walk 1 Direction	To N		X Walk 2 Direction	N/A
N/A	X Walk 1 Width (in)	N/A	N/A	X Walk 2 Width (in)	N/A
	X Walk 1 Slope (%)	6.4		X Walk 2 Slope (%)	N/A
	X Walk 1 X Slope (%)	4.8		X Walk 2 X Slope (%)	N/A

N/A	Ramp inside XWalk1?	N/A	N/A	Ramp inside XWalk2?	N/A
	Road Slope (%)	N/A	N/A	Clear Space?	N/A
	Road X Slope (%)	N/A	N/A	Clear Space to XWalk (in)	N/A
N/A	Any Obstructions?	N/A	N/A	Storm Grate/Utility Hazard?	N/A
	Obstruction Type			Storm Grate/Utility Type	
		N/A			N/A
			Yes	Surface Condition? (G/P)	Good

Remove & Replace Entire Ramp.

\$1850.00
